# Cross Plains, Texas Wildland Fire Case Study

This document was prepared by Texas Forest Service – Urban Wildland Interface Division and was completed on May 16, 2007. Any reproduction of this document should be copyrighted to Texas Forest Service.

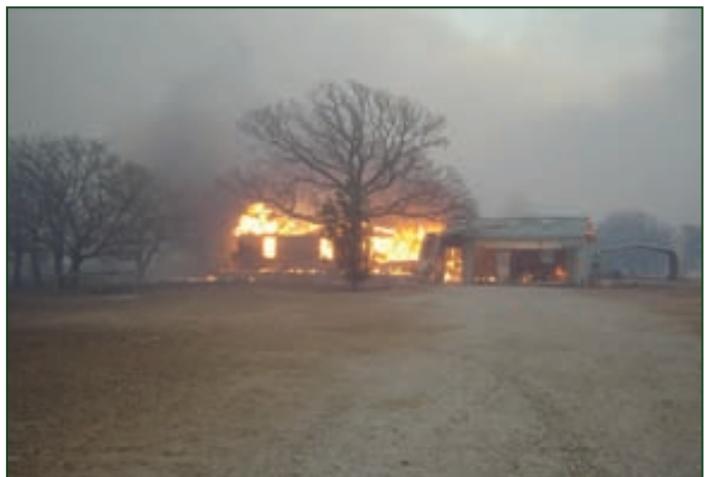
The cause of the fire was determined to be power lines popping together, with the origin being behind a home in an open field off FM 187, directly under the power lines. Reports stated that five volunteer fire departments arrived on site to assist with the fire. The entire town of Carbon was under both mandatory and voluntary evacuation. Fire behavior by eyewitness' reports exhibited flame lengths from 40-50 ft., with rates of spread of approximately 300 ft/min. Spotting was observed ranging from 1/4 to 1/2 mile. Weather for the area during active fire behavior was reported as winds W/SW at 35 mph with gusts up to 40-45, temperature of 84° F and RH of 10%. Extreme fire behavior was observed even into the evening as grass and brush actively burned at all times. Burnouts were conducted during the night, and ranchers were active, using cattle sprayers, etc. The fire burned 35,300 acres and destroyed eight homes. Several homes with metal roofs burned to the ground because of unscreened wooden decks or open attic vents.

estimated winds in the fire front at 70 mph, based on his visual observation of large oak trees bending. The leading edge of the fire was observed carrying coastal hay and other burning debris embers. One home that was lost was constructed of brick with a steel roof and concrete porches. It survived the initial flaming front, however, within 30 seconds of the main fire passing, the home was fully engulfed.

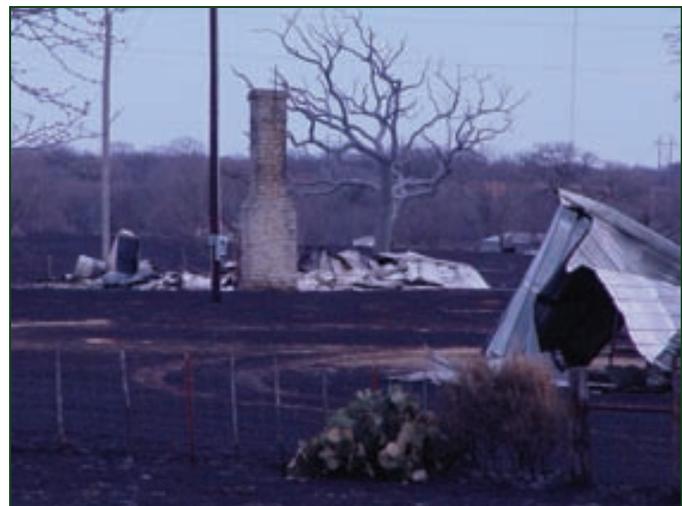
The origin of the fire was determined to have been on Diamond Ranch, west of Huckabay, and was attributed to downed power lines. Starting at 12:30, January 2, 2006, the fire actively burned with 4 ft. flames in mowed grass, fire whirls jumping 40-50 ft. and 11 ft. flames noted through flanks. Winds of 28 mph with gusts 40+, temperature of 85° F, and RH of 11% facilitated the fire to burn 10,000 acres, destroying six homes and 21 outbuildings. In a town of only 200, every melted mobile home and blackened yard still moves firefighters to tears. Homeowners and fire personnel watched as backing fires spread to homes that had survived the initial fire front but now ignited from the smallest flame. Recurring causes of ignition for homes included wooden decks, unscreened attic vents and wooden post-framed additions.

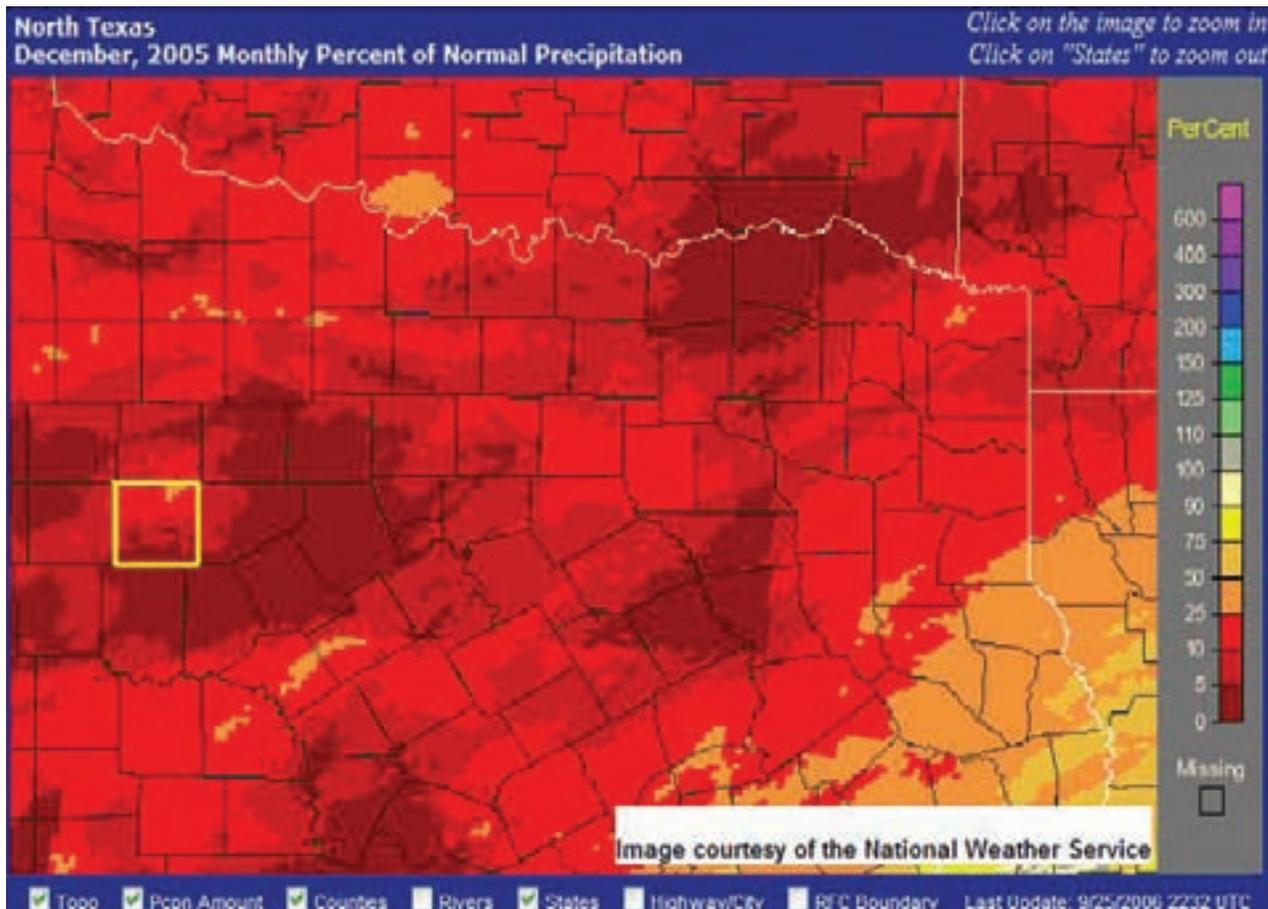
Figure 4 – Monthly percent of normal precipitation for North Texas in December 2005.

Since the nearest weather station is 30+ miles away, NEXRAD radar was used to estimate rainfall for the Cross Plains area. Above average rainfall experienced during the spring and summer began to taper off in the month of September. During September, the Cross Plains area received only 0.63 inches of rainfall (22% of normal). October wasn't much better, with the area receiving 0.73 inches (25% of normal). Drought conditions began to accelerate in November, and Cross Plains received no rainfall for the month. December 16 would be the last rain event before the fire occurred. On this date, NEXRAD estimates 0.08 inches of rain fell; hardly beneficial. Figure 4 demonstrates the monthly percent of normal rainfall for much of North Texas during December. Southeast Callahan County received less than 10% of normal rainfall during the month of December. The Cross Plains area received 17% of normal rainfall for the period of September through December.

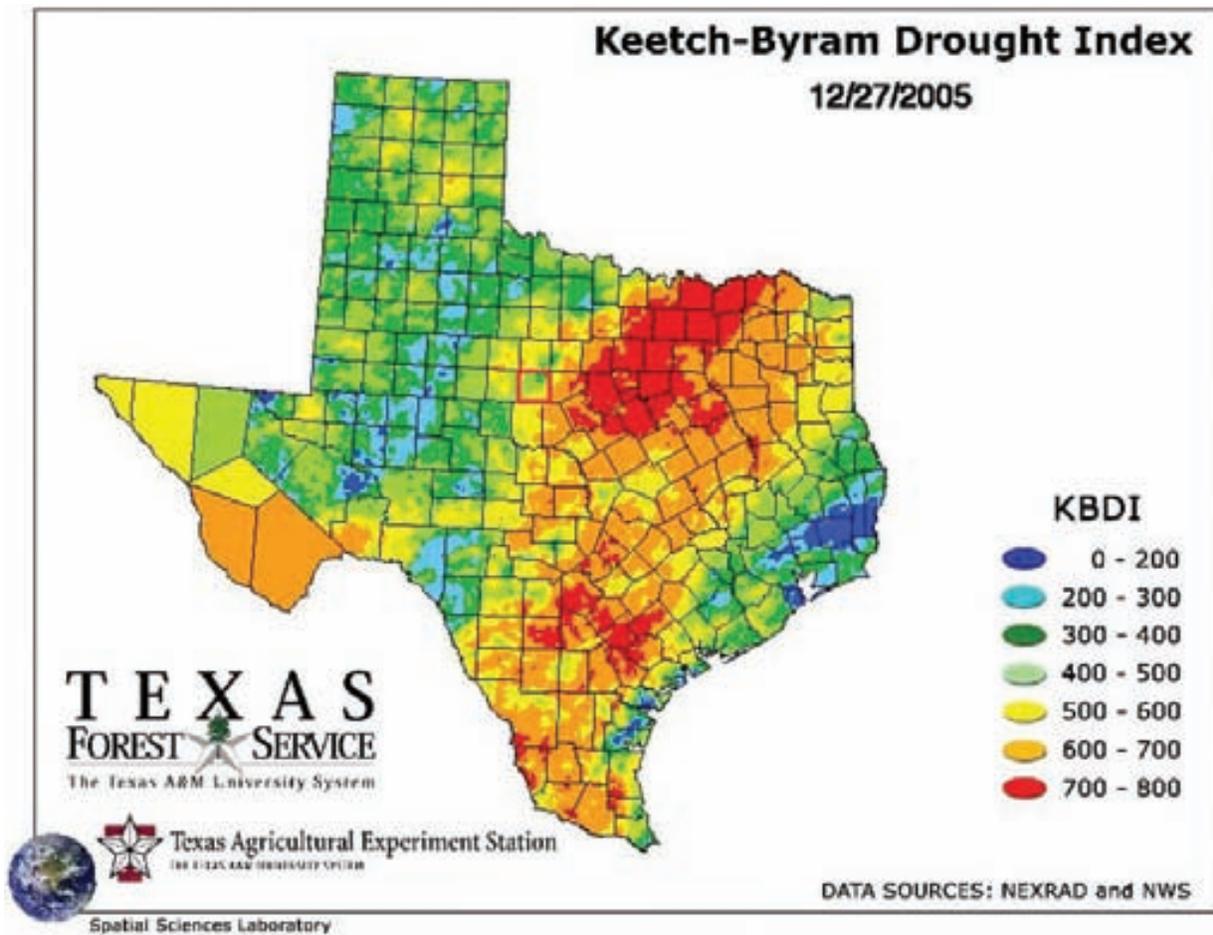
Figure 3 – KBDI for December 27, 2005.

Normally, the KBDI averages between 200 and 237 during the month of December at the Hamby weather station. When KBDI rises to 550 or higher, drought becomes a significant factor. The KBDI reached 550 at Hamby on December 2. Figure 3 illustrates the KBDI on December 27 for the state of Texas based on a 4 kilometer grid. The Callahan County boundary is outlined in red.

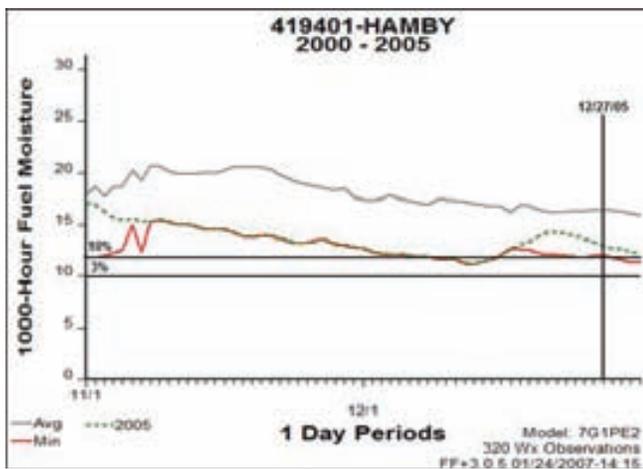
Figure 4 – 1,000-hour time lag fuel moistures calculated by Fire Family Plus using data from the Hamby RAWS Nov. 1 - Dec. 31, 2005.

At the beginning of November, 1,000-hour dead fuel moistures at Hamby were in good shape. (Figure 4) Dead fuel moistures greater than 16% are generally considered to have above normal moisture in areas represented by the Rolling Plains PSA. Over the course of the next 4 1/2 weeks, 1,000-hour fuel moisture contents dropped to critical levels. They rose slightly after mid-December but were trending back downward prior to the fire. The 1,000-hour fuel moisture is another good indicator of long-term drying.

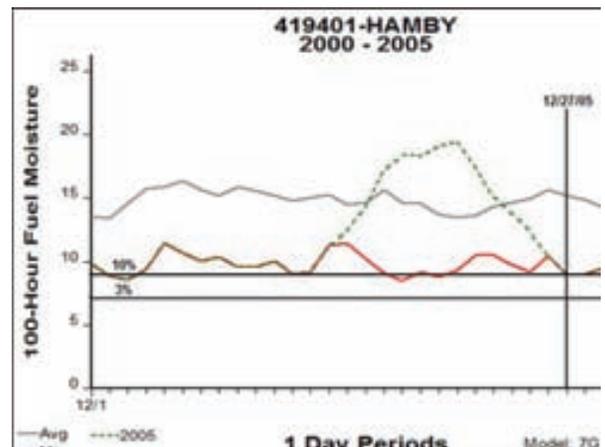
Figure 5 – 100-hour time lag fuel moistures calculated by Fire Family Plus using data from the Hamby RAWS Dec. 1 - Dec. 31, 2005.

The time it takes for 100-hour dead fuel moistures to respond to increases or decreases in moisture is considerably less than the 1,000-hour fuels. Figure 5 displays the 100-hour fuel moisture trends through the month of December. At Hamby, the 100-hour fuel moistures during the first two weeks of December were at or slightly above critical levels. They rose to above average levels from December 16 – 21 before making a steady drop back to critical levels over a six-day period. Many of Texas' largest fires have occurred when 100-hour fuel moistures were at or below critical dryness and when the Energy Release Component (ERC) in fuel model 1978 G (short needle conifer) reaches its critical thresholds as well.

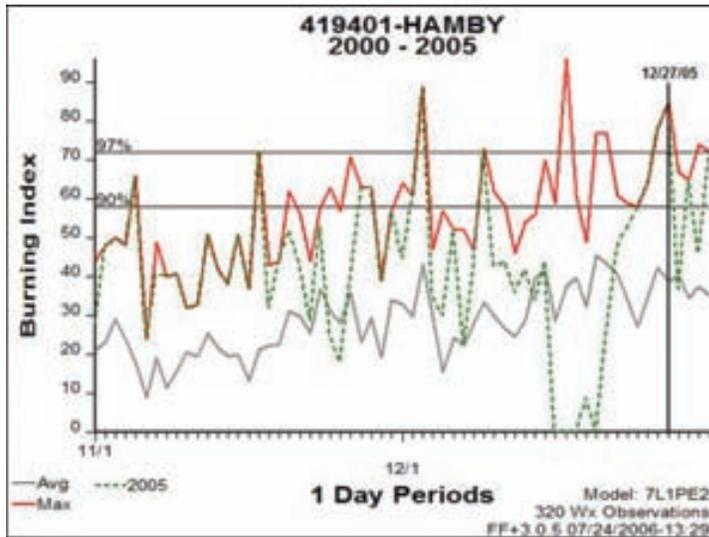
Figure 6 – Burning Index values calculated by Fire Family Plus using data from the Hamby RAWS, Nov. 1 - Dec. 31, 2005.

The Burning Index (BI) exceeded the 90th percentile multiple times from November 1 - December 31. (Figure 6) The BI dropped at or near zero for a five-day period from December 16 – December 20. On the 21st, BI began to rise and exceeded the 90th percentile again the day after Christmas. Fuel model 1978 L (Western perennial grass) was used to model the conditions. Grass is usually where most fires initiate in the Rolling Plains PSA. The BI in fuel model 78L correlates well with large wind-driven fires because its calculations are weighted heavily on wind and 1-hour dead fuel moistures.

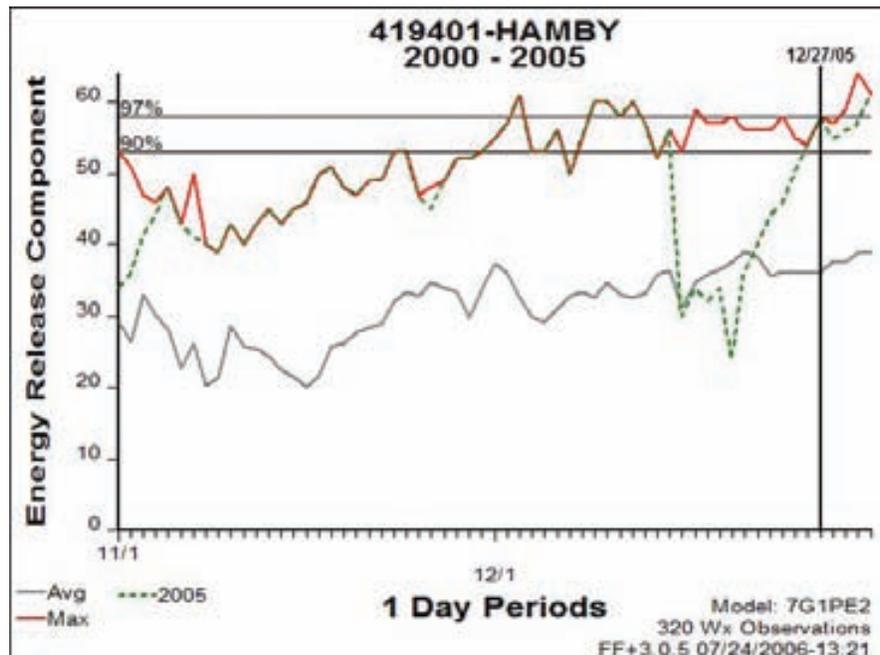
Figure 7 – ERC values calculated by Fire Family Plus using data from the Hamby RAWS, Nov. 1 - Dec. 31, 2005.

In Figure 7, the ERC was near or exceeded the 90th percentile from November 29 – December 14. The ERC dropped near average for a short time before rising sharply (34 points) over an eight-day period. Fuel model 1978 G (Short needle conifer) was used because all classes of live and dead fuels are represented in the model, making it a good tool to track seasonal severity. As previously stated, many of Texas’ largest wildfires have occurred during periods when ERC 78G and 100-hour fuel moistures are at critical levels.

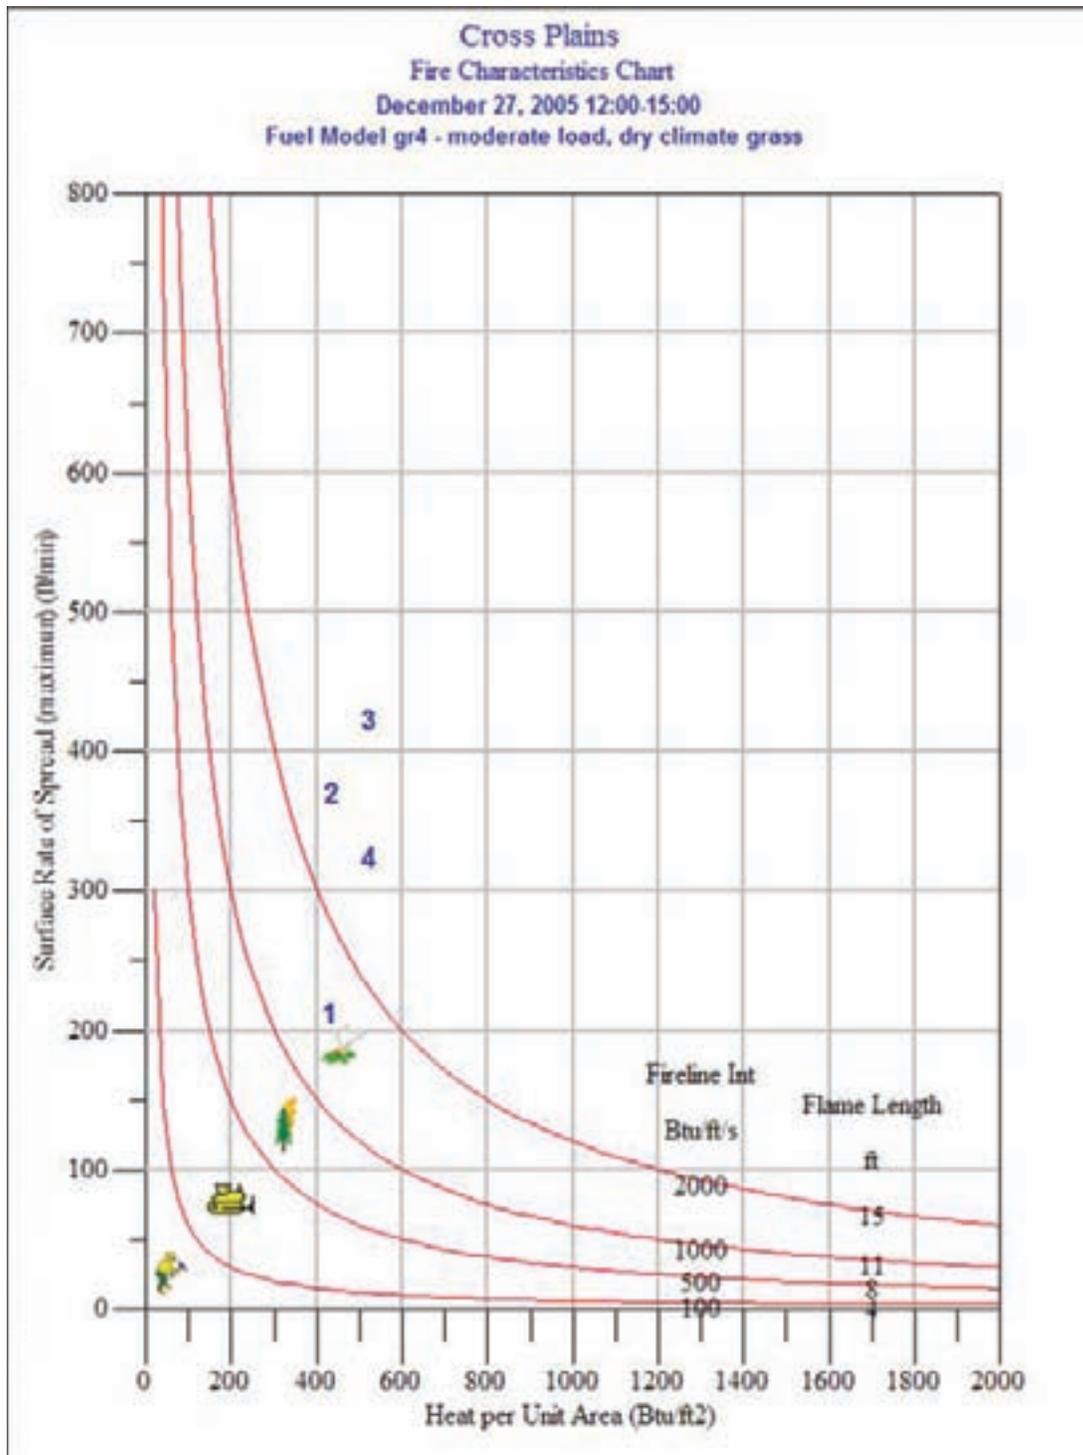
Figure 10 – Fire characteristics chart created in Behave Plus using the gr4 fuel model and weather data from the Hamby RAWS.

From the time the fire initiated, it was beyond the control of mechanized equipment. Points 1 – 4 are plotted on Figure 10 to illustrate Surface Rate of Spread (ft./min.) over Heat per Unit Area (Btu/ft<sup>2</sup>), based on the four most critical hours of the event (12:00 – 15:00).

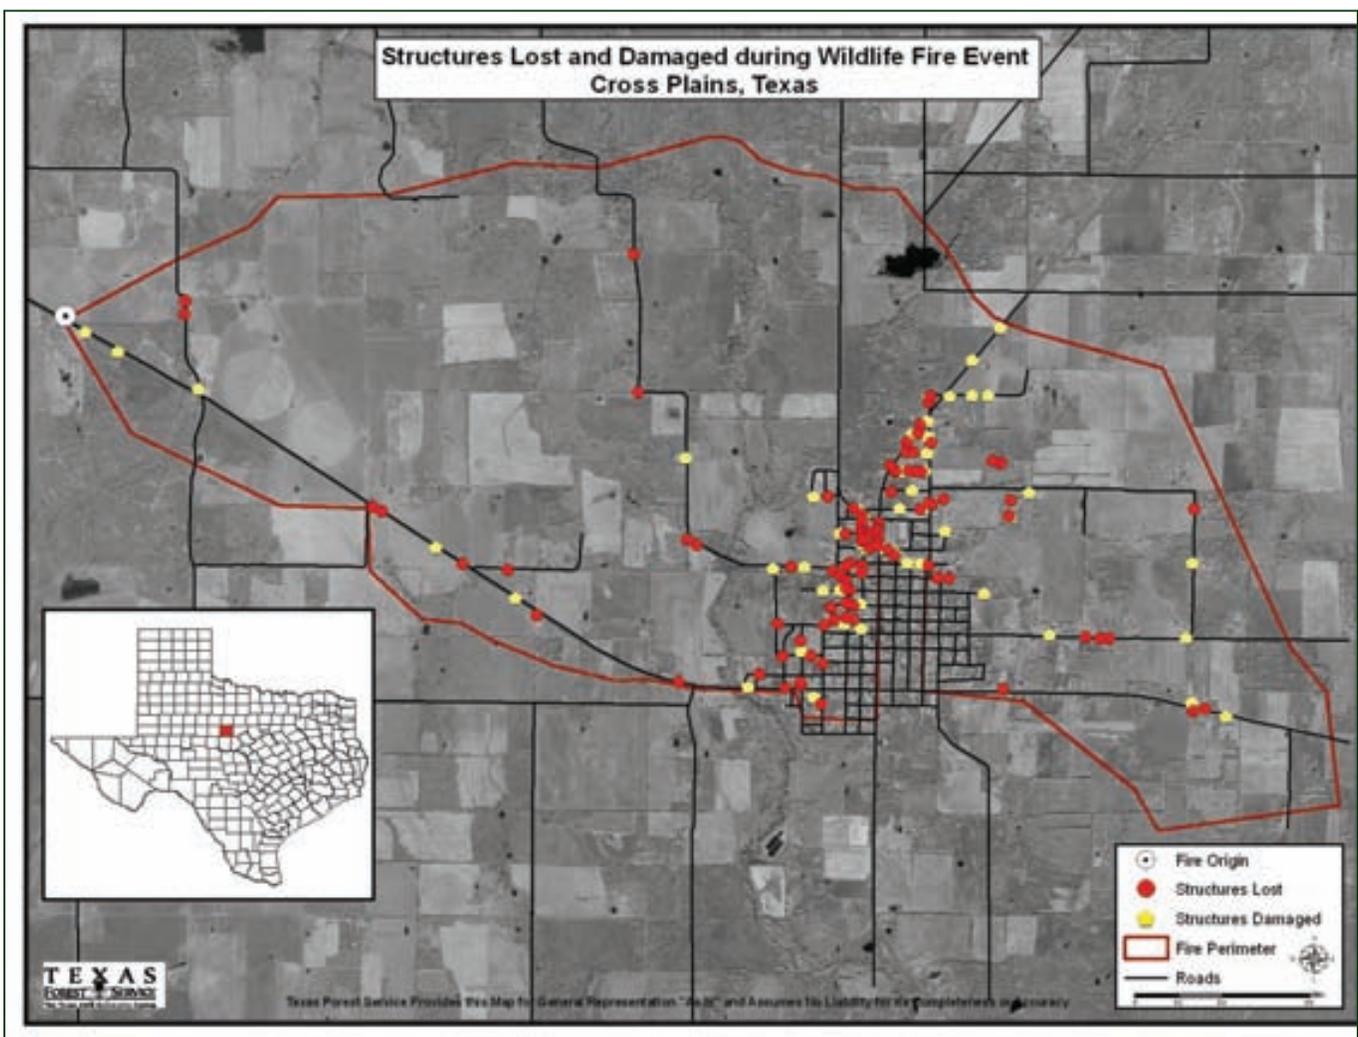
Figure 11 – Structures lost and damaged during the Cross Plains wildland fire event.

Figure 11 shows an overview of the fire's perimeter and all homes lost or damaged during the fire event. Onsite data for homes lost or damaged was collected using Garmin Etrex Legends coordinated with tax appraisal cards for accurate verification of structures. The map was created in ESRI software ArcMap version 9.1, using Texas Natural Resources Information System data utilizing Stratmap transportation and 30 meter – 2004 National Agriculture Ortho-imagery (Map Projection information: NAD 1983, UTM Zone 14 Meters).

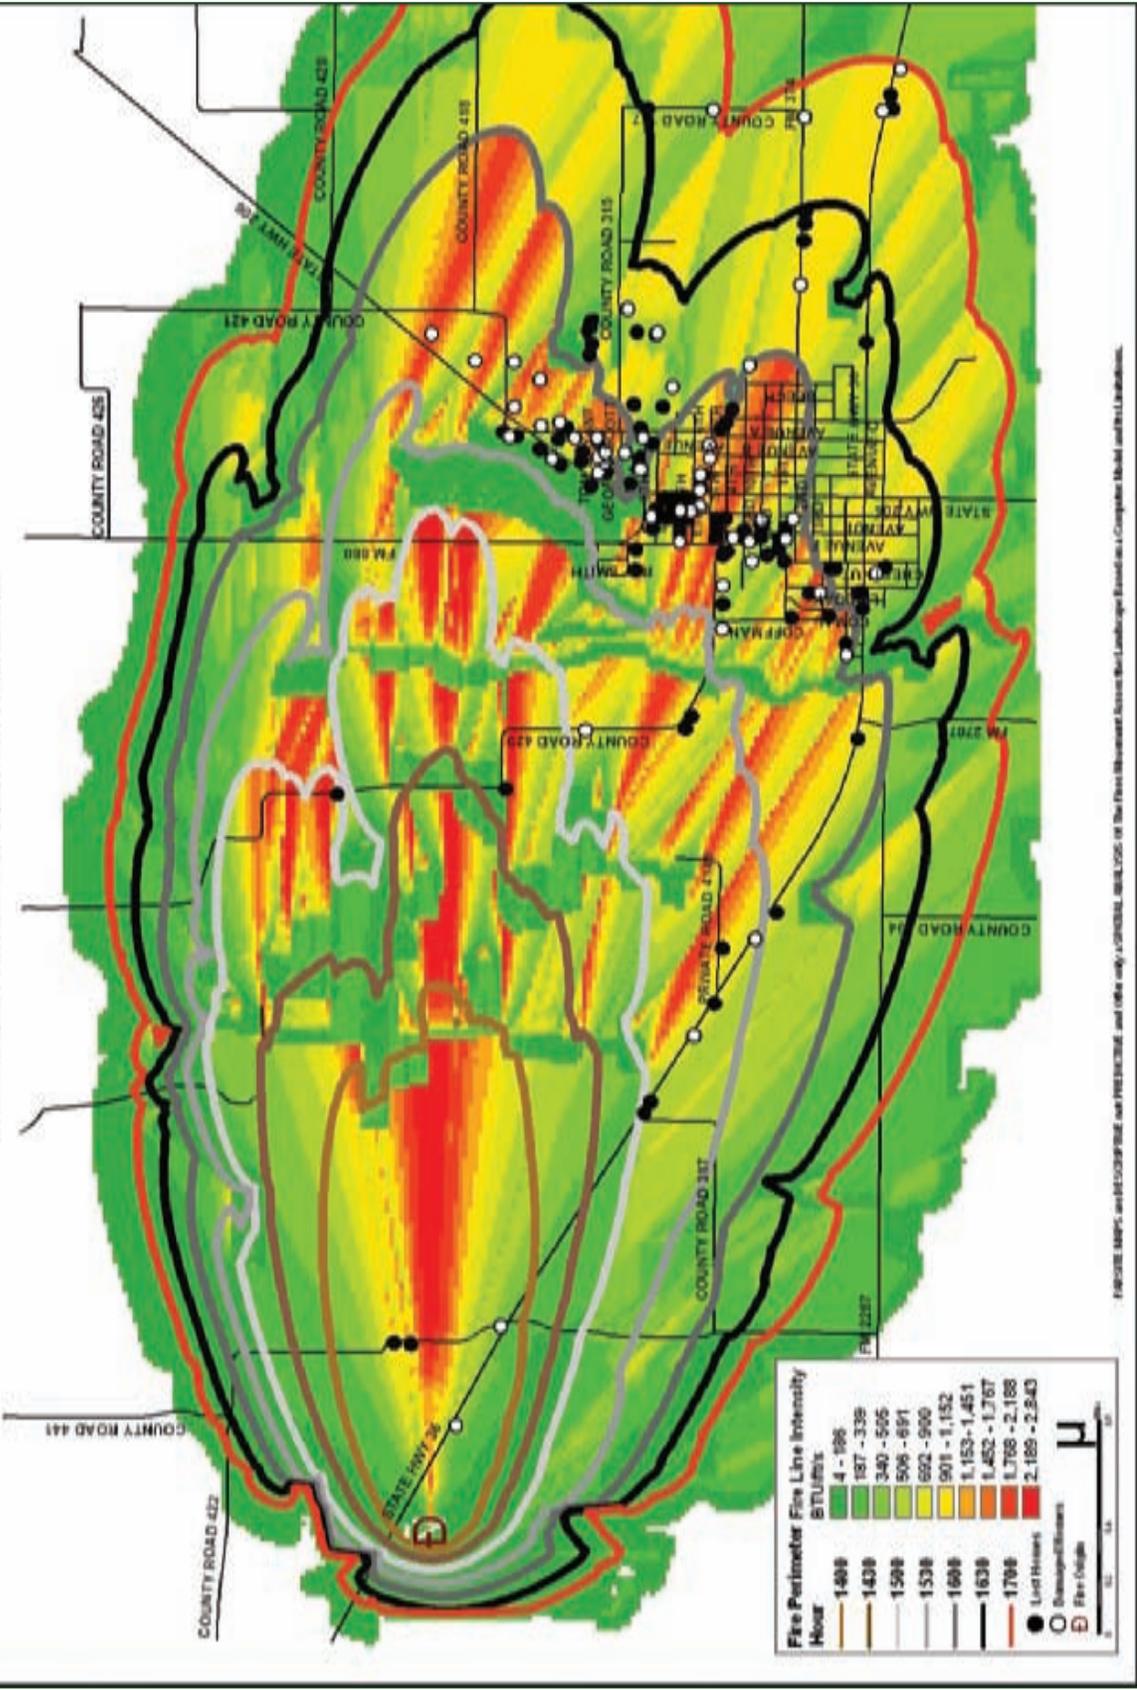
Figure 13 – Fire line intensity.

# FARSITE - Fire Line Intensity (BTU/Feet/Second) Cross Plains Wildfire Event

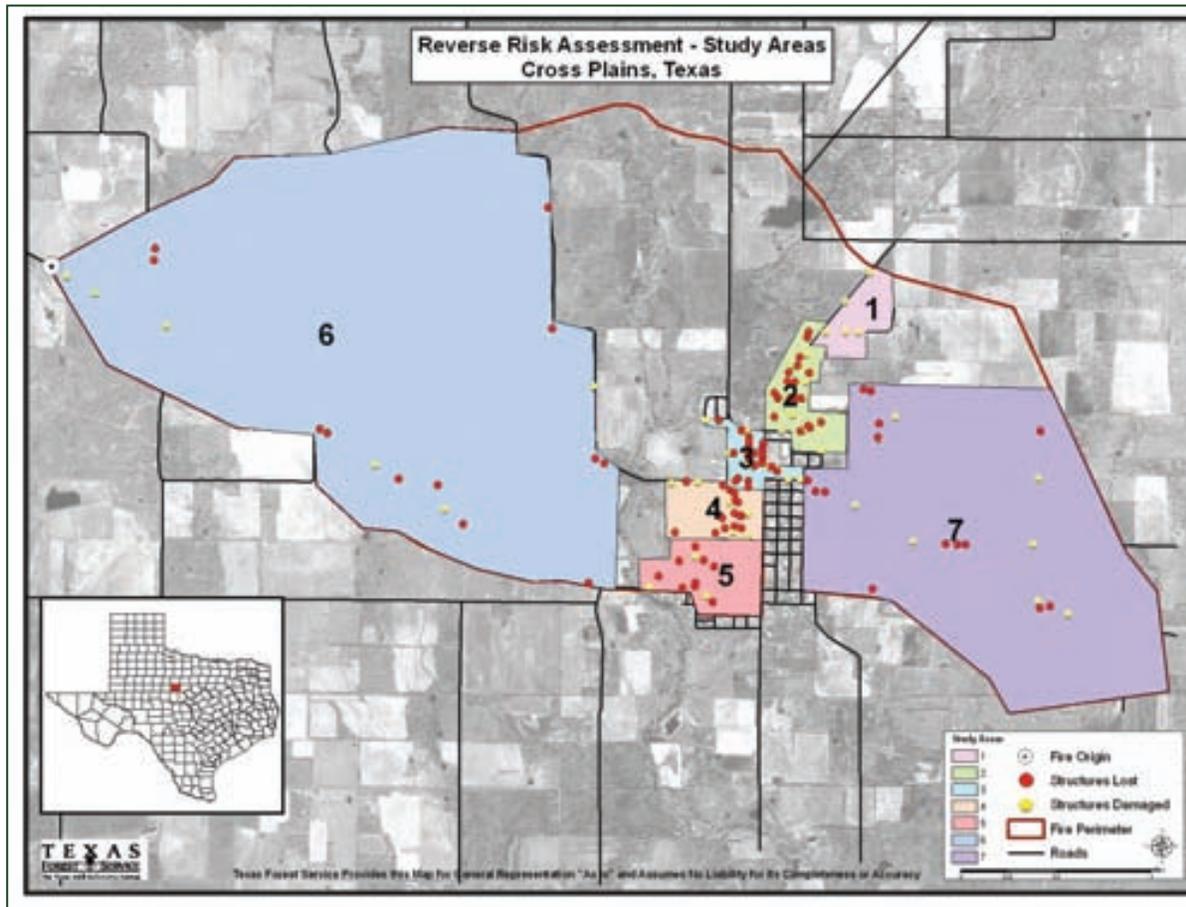
Figure 15 – Study areas for reverse risk assessment.

Home losses during the Cross Plains fire have been broken down into seven primary study areas based on fuels and fire behavior in that unit. (Figure 15) This section of the case study will discuss the nuances involved in home ignition throughout the Cross Plains fire, as well as common denominators on the other fires within the study area. The entrance of fire on the leading edge into town was characterized by two scenarios: fire spread being pushed by extreme winds through predominately fine continuous herbaceous grasses; and open shrub overstories comprised of oak, cedar and yaupon with fine herbaceous grass understory. As the fire approached the community, radiant heat raised ambient temperatures and preheated flammable homes and vegetation in the path of the fire. The primary mechanism for home ignition during this fire was embers rolling along the ground and being carried aloft. These grass embers caused numerous spot fires, easily jumping roads, complicating fire suppression efforts and increasing the risk to residents and firefighters. Many homes were impacted by direct flame contact as fire traveled through short grass leading directly to structures. It was very often the case that the fire moved so quickly through an area that residual heat sources caused losses to occur after the main fire had passed. This direct flame contact occurred due to lack of breaks in continuous fuel beds such as residential lawns and landscape materials. Fire behavior outputs described in the study areas are based on outputs from BEHAVE Fuel Model GR4 and are described as a moderate load dry climate grass. Fuel Model 2 is described as a timber with grass and understory, and Fuel Model 9 is described as a hardwood litter.

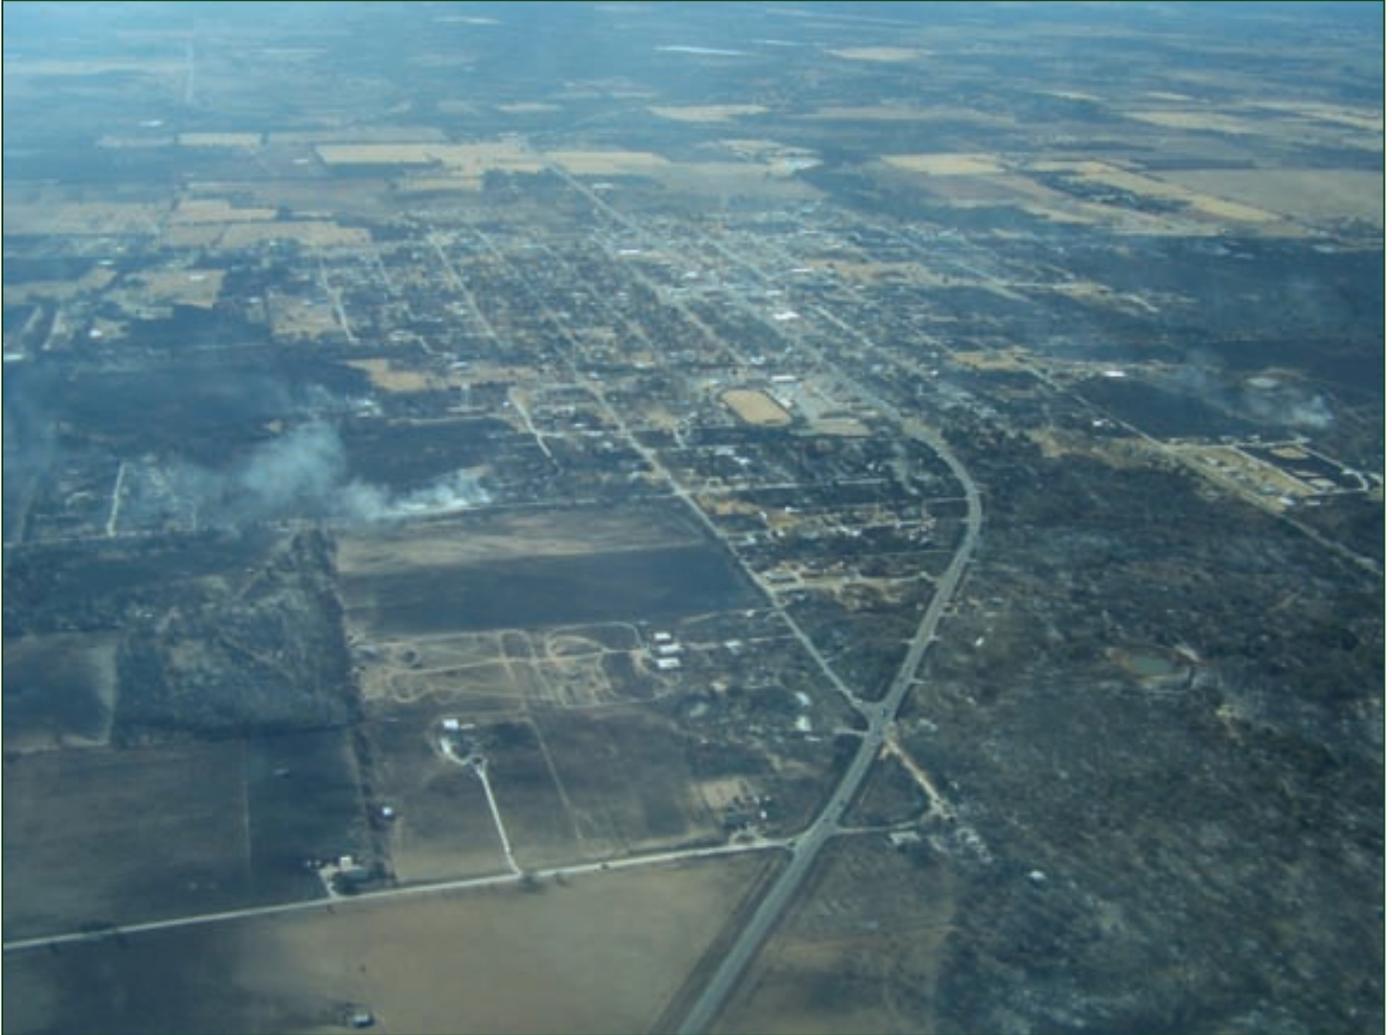
Fire entered this area from a native grass field located in the northwest portion of Area 1. This area is adjacent to a plowed field located to the north of Area 1. Homes located in Fuel Model GR4, transitioning from a Fuel Model 2 located on the east side of State Hwy. 206, were impacted by the wildfire at approximately 17:15. As the fire front passed through Area 1, the rates of spread were 324 ft/min with sustained winds. Flame lengths were 17 ft. and fire line intensities were 2507 btu/ft/sec. Crossing State Hwy. 206, the fire approached two brick homes with manicured lawns and good defensible space. Jumping County Road 421, the fire went through a coastal Bermuda field which was close to knee-high, where eye witnesses saw 20-30 ft. flame lengths. Three brick homes were threatened after the fire jumped the gravel road. One brick home was damaged due to vegetation in contact with the roof's unenclosed soffits. Another brick home, 4, was lost due to a wooden deck located behind the home. An eyewitness homeowner stated that home 3 burned from behind, where smoldering embers under the deck caused the house to ignite. It is theorized that the plowed field north and northwest of Area 1 may have influenced the fire behavior by slowing the rate of spread and reducing heat outputs, a factor in saving these homes.

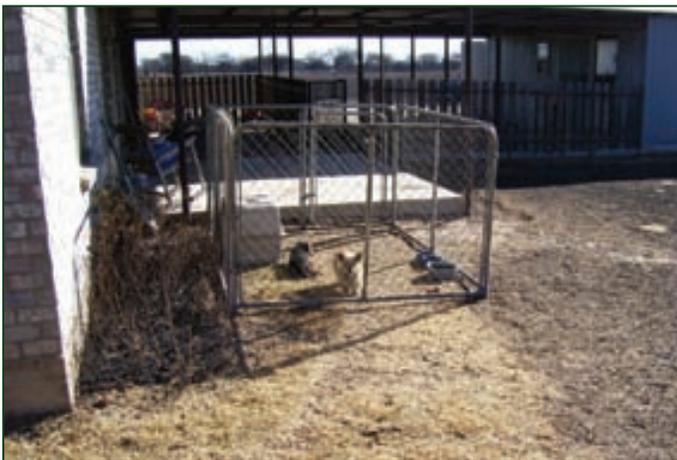
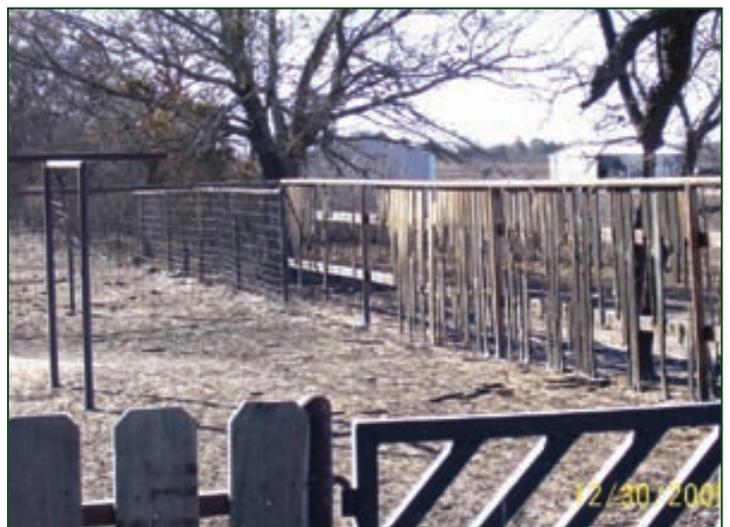
### **A Closer Look at Home 4**

The homeowner provided structure protection for this property. Although they lost their water supply from the well due to compromised electricity, they were able to use a horse trough onsite for a water source to extinguish the fire between the dog pen, the house and the burning fence line toward the home. The homeowner stated that the fire front had burned past the home, but a dramatic wind shift caused the fire to turn and put their home in direct threat from the newly created fire front.

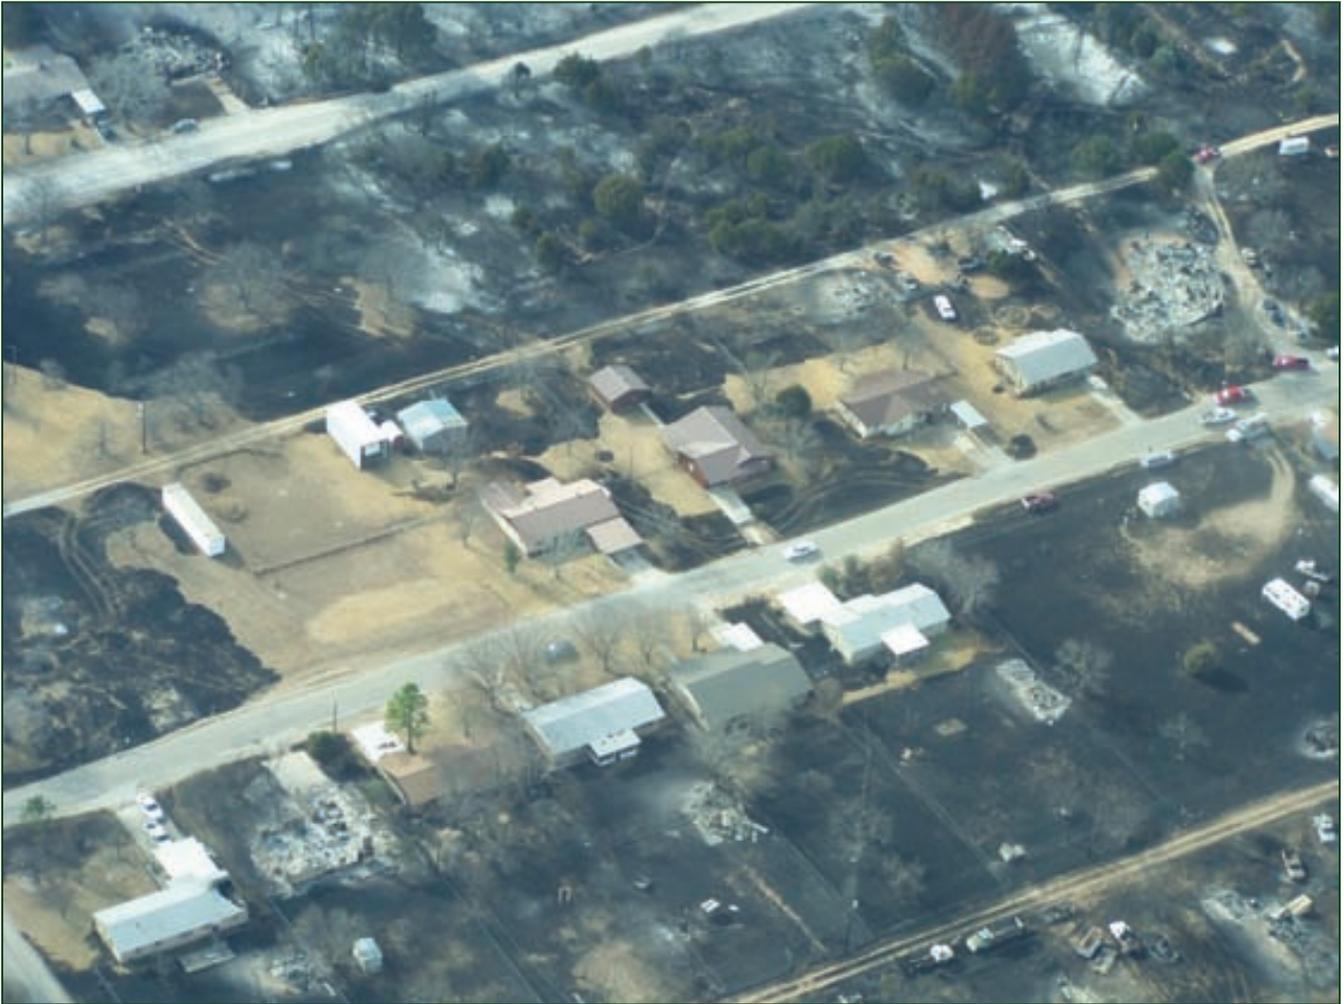
Homes were impacted directly by the leading edge of the fire coming out of a Fuel Model 2 located on both the east and west sides of State Hwy. 206. Fire activity in this area displayed rates of spread of 180 ft/min, flame lengths of 13 ft. and fire line intensities of 1584 btu/ft/sec. The flaming front moved through an over-story of post oak, with mid-story fuels of mesquite, greenbrier, yaupon and native grasses as the primary carrier of fire. After crossing County Road 421, a change in wind direction from the north caused the flaming fire front to turn in a southerly direction, creating a flanking fire which made a run through native grass and Bermuda fields with heavily matted fuels. The new head fire created a v-pattern with the opposing flanking fire coming from the west, sandwiching Area 2 between two opposing flanking fires and causing intense fire whirls and fire behavior. Eye witnesses on the west side of State Hwy. 206 stated the winter leaves of the post oak trees were bursting into flames before the flame front actually made it to the residence. Surrounding the Methodist church at the southwest corner of the area are the remnants of an exotic conifer plantation. Trees identified include blue spruce, shag pine, Arizona cypress, Leland cypress, red cedar and arborvitae. On the northwest side of State Hwy. 206, the fields were thick with post oak, cedar, juniper and mesquite, with excessive ladder fuels. The area located on the east side of State Hwy. 206 generally consisted of manicured lawns and homes constructed of brick or other masonry.

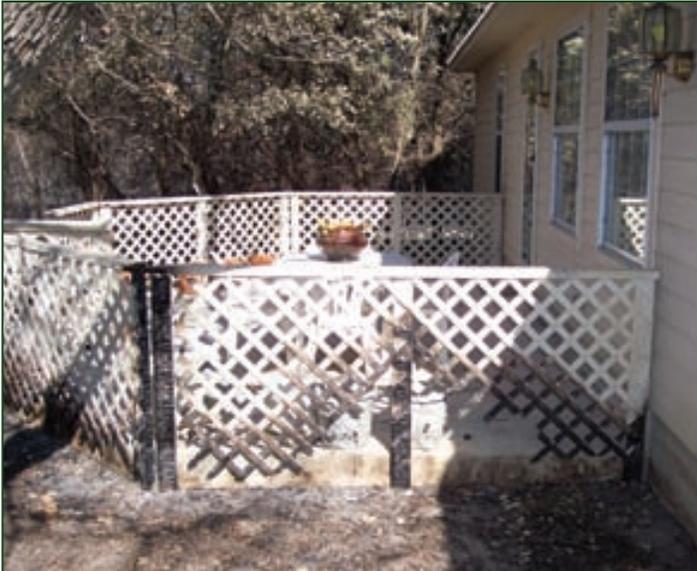
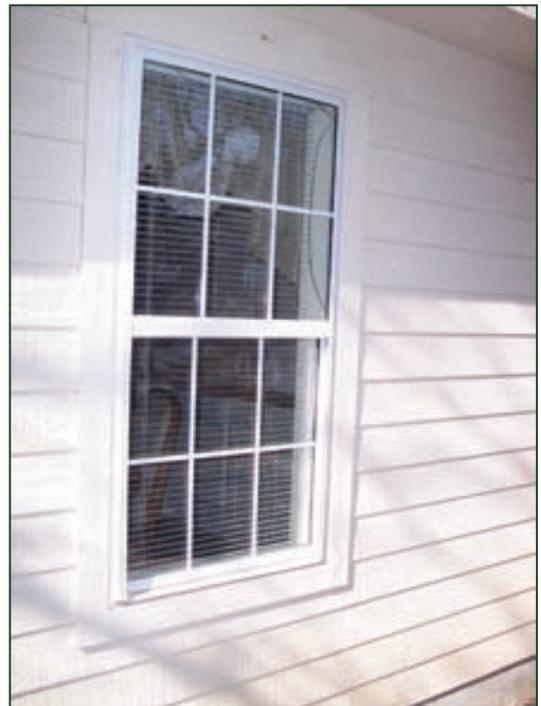
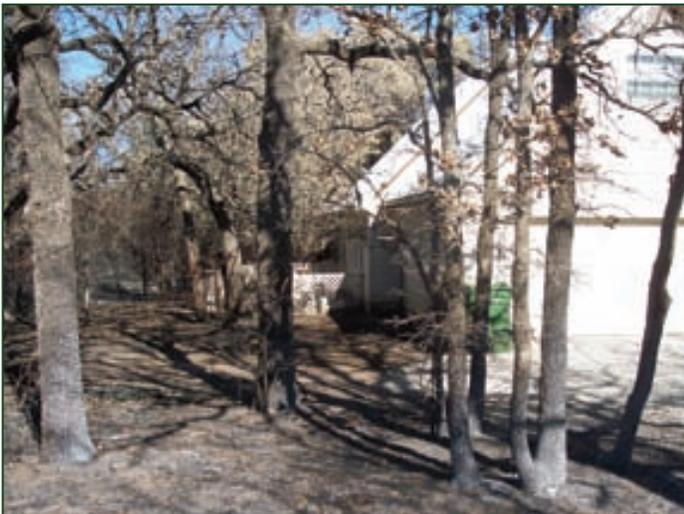
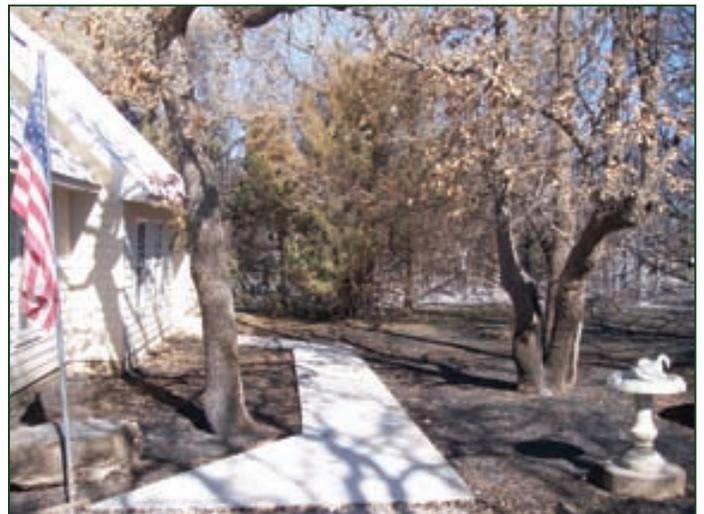
Lattice burned on back porch

Fire resistant building materials were used in the construction of this home. The roof is metal with hardy plank siding and a concrete foundation. Even though the fire burned up to the structure, this portion did not ignite. Although the windows on this home were double-pane, the minimal leaf litter generated enough heat intensity to break the first pane, but did not compromise the interior.

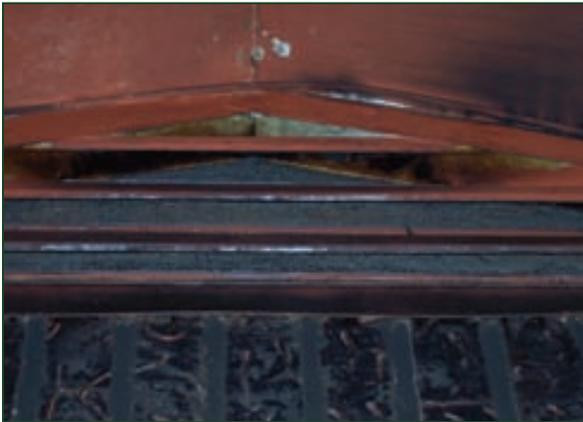
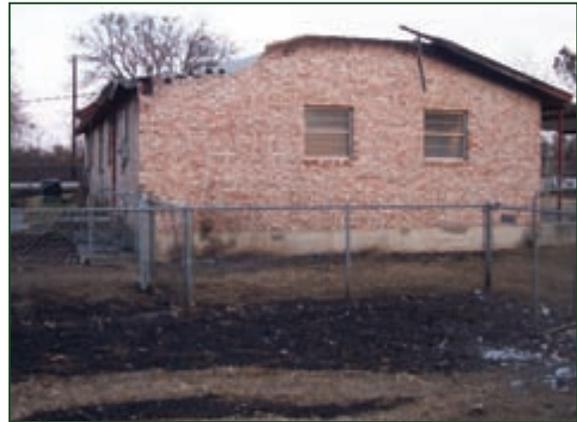
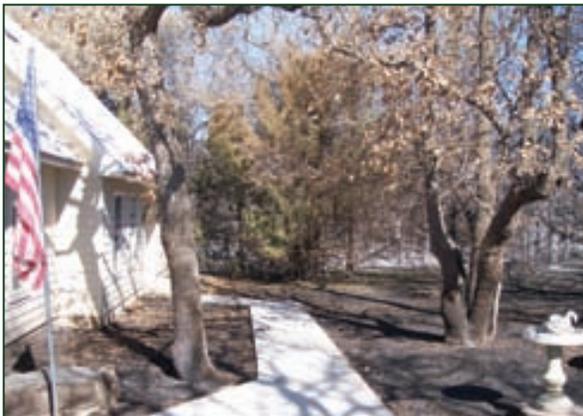
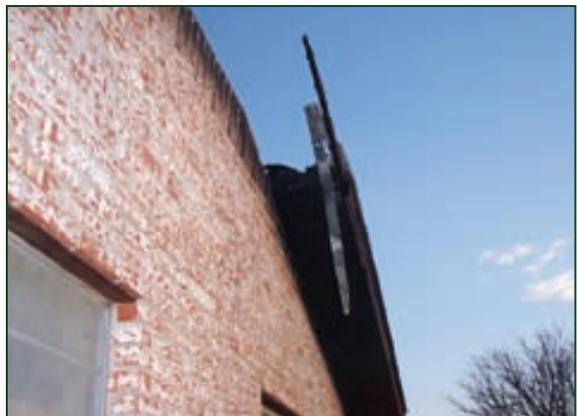
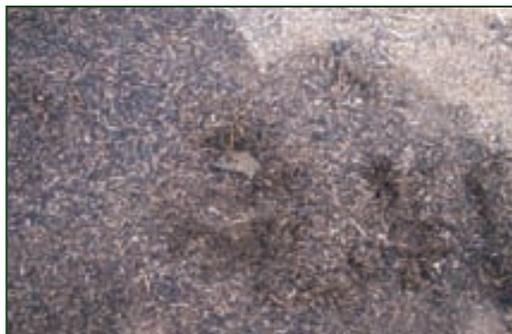
The house appeared to have burned from the inside out.

Although the adjacent structure burned, the fuels between the two structures were not consumed. Structure-to-structure ignition from radiant heat was not the most likely cause of these home ignitions. Unconsumed shrubs and grass indicate that ignition from landscaping was not the principle factor involved in the ignition. Fine ember firebrands were noted. They had accumulated near the homes and penetrated any access point on structures in the fire's path, such as attic and foundation vents. This can be seen in the profuse amount of grass embers caked against screens. Grass embers were such that the 1/8" screen which would normally be adequate to keep embers in a timber fuel type from entering the attic and compromising the structure were inadequate in this instance.

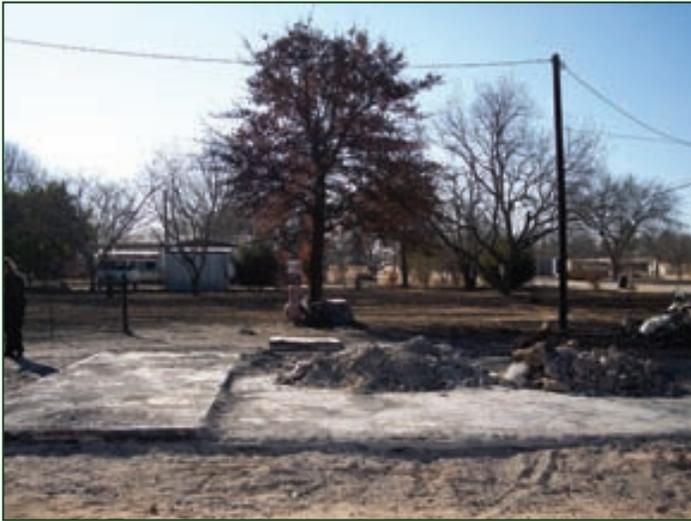
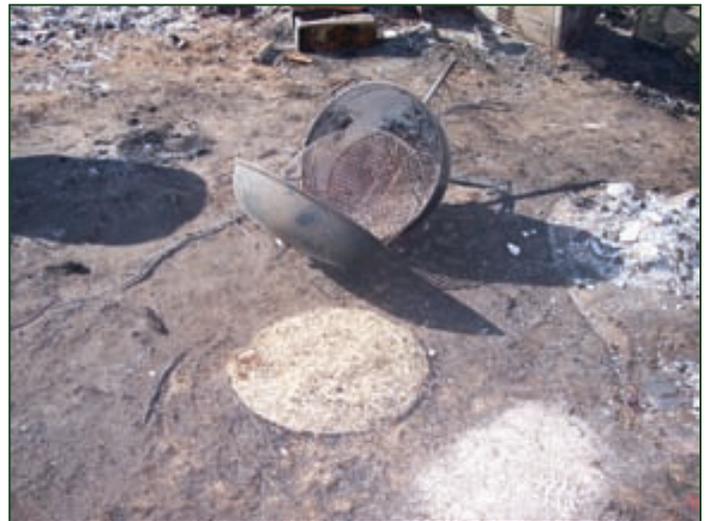
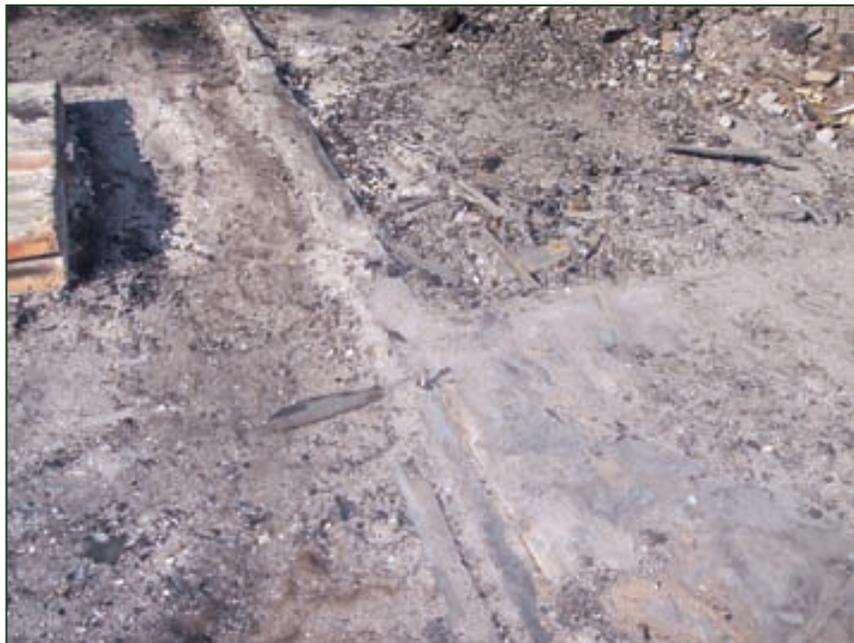
**A Closer Look at Home 34:**

Older manufactured home with metal skirting

Wooden frame car port was point of exposure

The carport was supported by wooden beams with a composite asphalt overhang that ignited due to direct contact with the wooden beams.
