# Cross Plains, Texas Wildland Fire Case Study

This document was prepared by Texas Forest Service – Urban Wildland Interface Division and was completed on May 16, 2007. Any reproduction of this document should be copyrighted to Texas Forest Service.

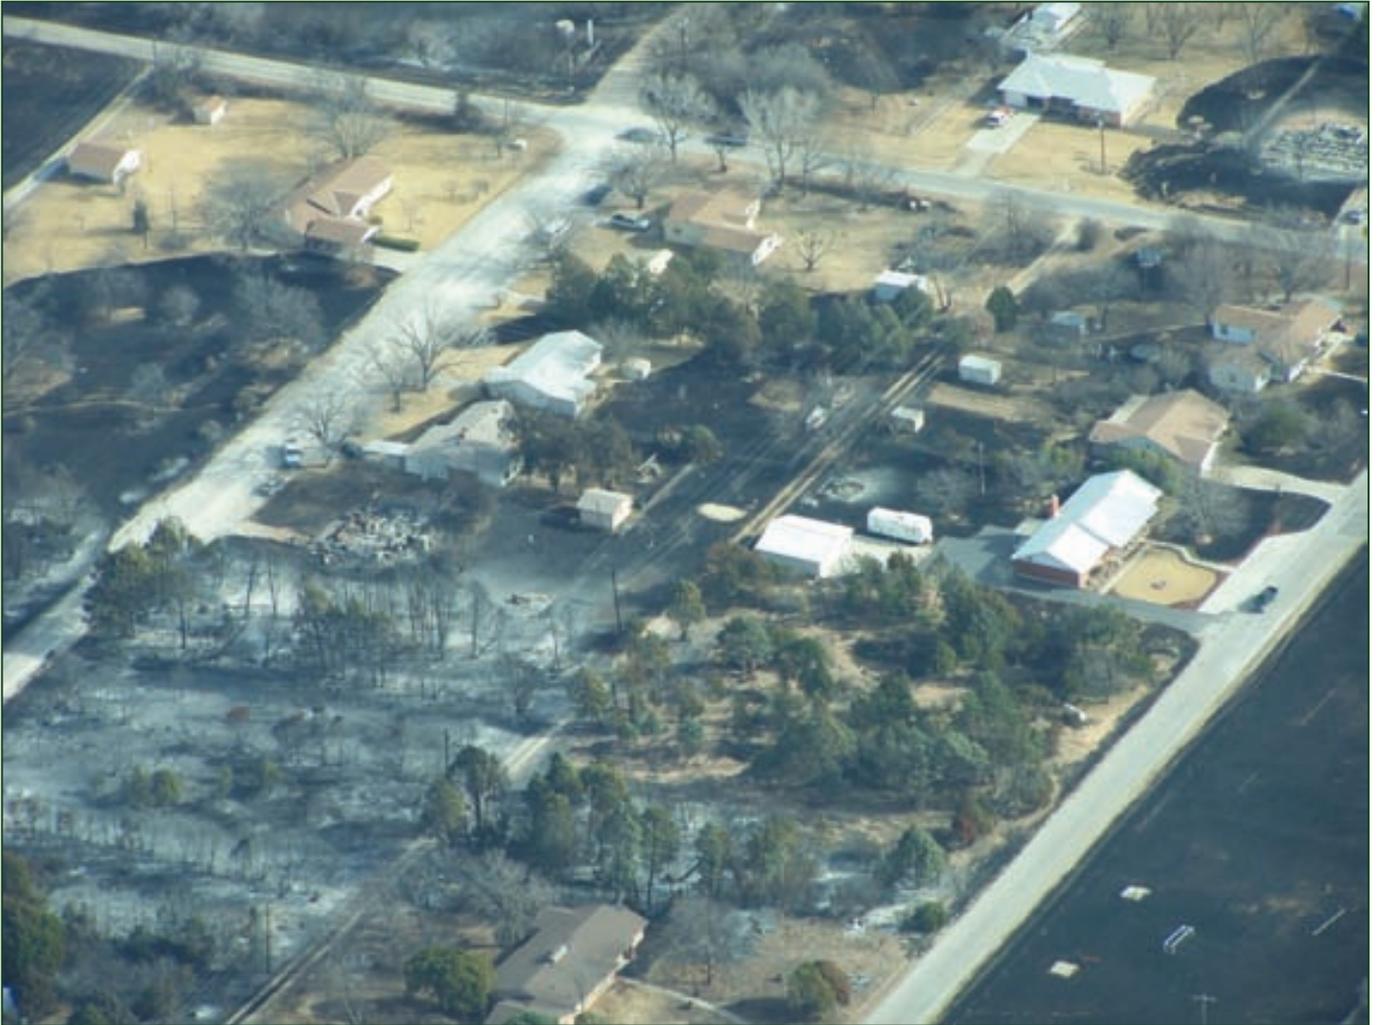
The fire aggressively burned through Fuel Model 9 prior to entering Fuel Model 1 on the west side of State Hwy. 206 in which the homes were located. Fire activity in this area exhibited rates of spread of 34 ft/min, flame lengths of 6 ft. and fireline intensities of 232 btu/ft/sec. This area includes Main Street and is more or less the center of town. The fire came across a native grass and mesquite field. Eyewitnesses saw 40-50 foot flame lengths. Most of the structures in this area are pier-and-beam construction with a crawl space. The lawns are not quite as manicured as seen in Area 2. Lots consist of oak and pecan, with intermittent juniper. It is postulated that the large masonry structure of the school compressed the flame front, not letting the heat escape. The reflective heat from the school, and the radiant heat from the structures before it that had already caught fire, created a chain reaction among the houses and structures along Main Street, causing total losses of homes along the block across from the school. The water-manicured baseball field in the northwest side of Area 3 may have played a role in the loss of only one home in the southwest corner of the complex. Perhaps in the future, the community could utilize this field as a maintained safety zone.

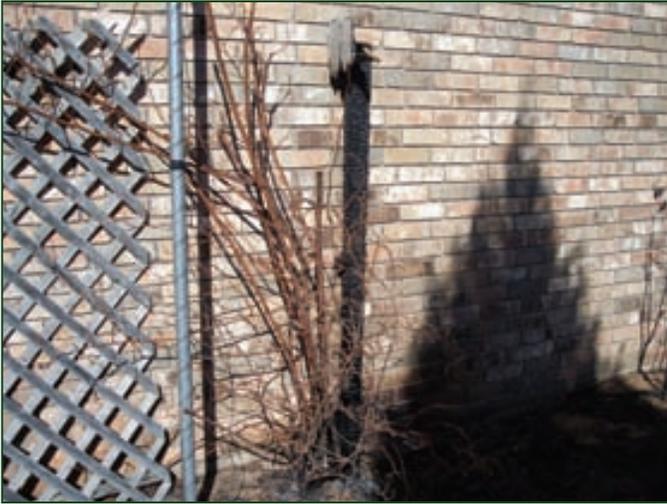
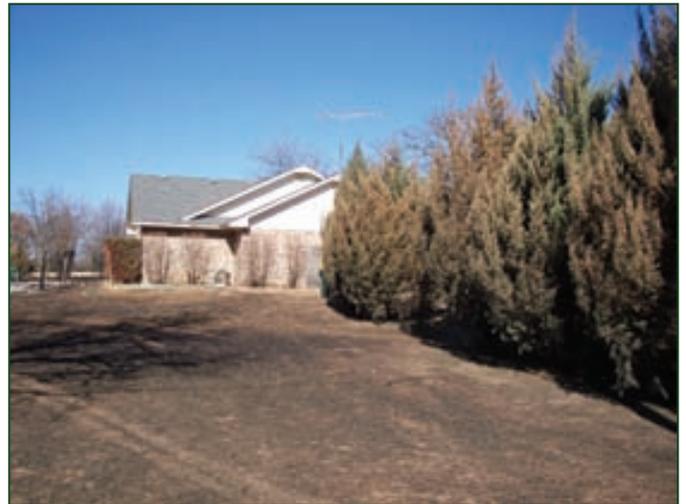
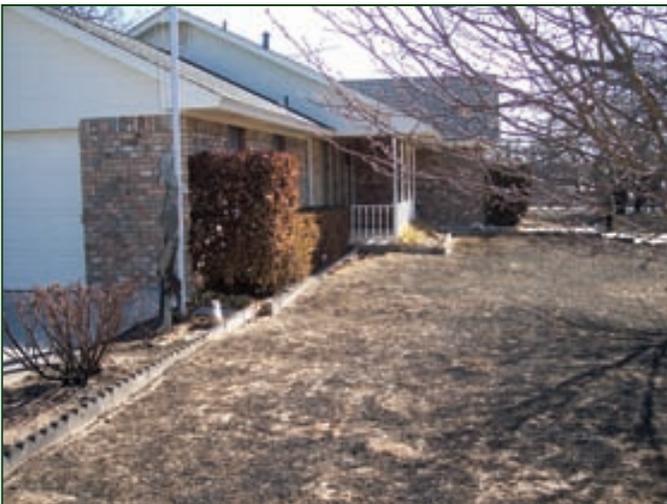
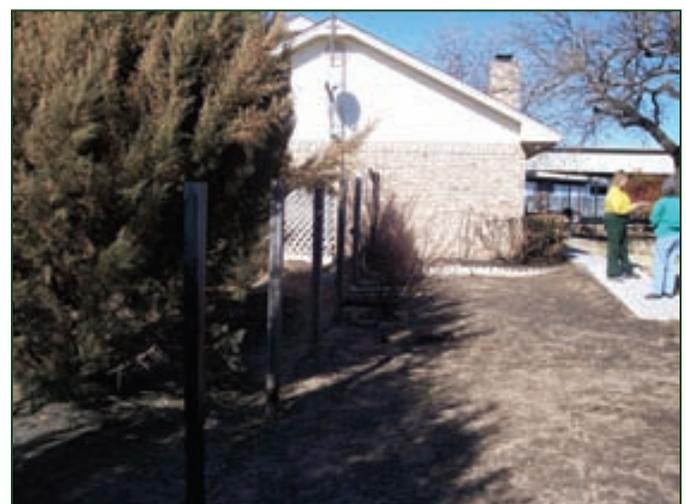
Concrete slab

Deck metal post and roofing

The wooden fence that led up to and is connected to the home caught fire after the main fire front had passed, and active flames persisted along the fence line through the night and into the following day. Homeowners put out the fire and monitored the fence for 24 hours. They went through two hoses, due to melting, and during the course of the evening, residents lost electricity to the well and were forced to use onsite water with buckets. Arizona cypress, considered highly volatile, received only minimal scorching due to the speed at which the fire traveled across the landscape.

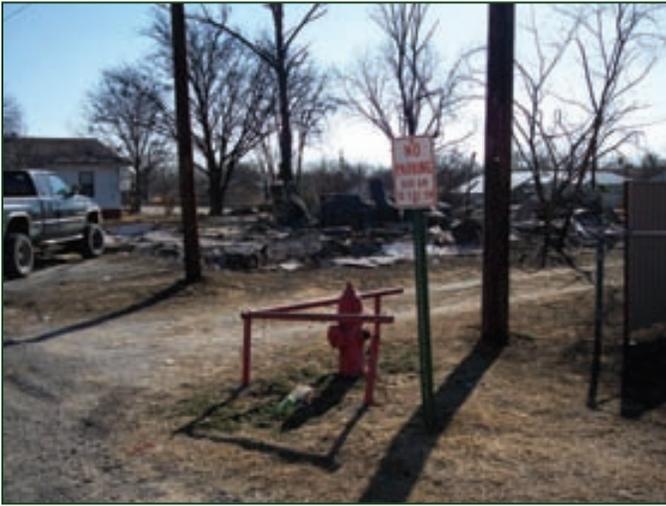
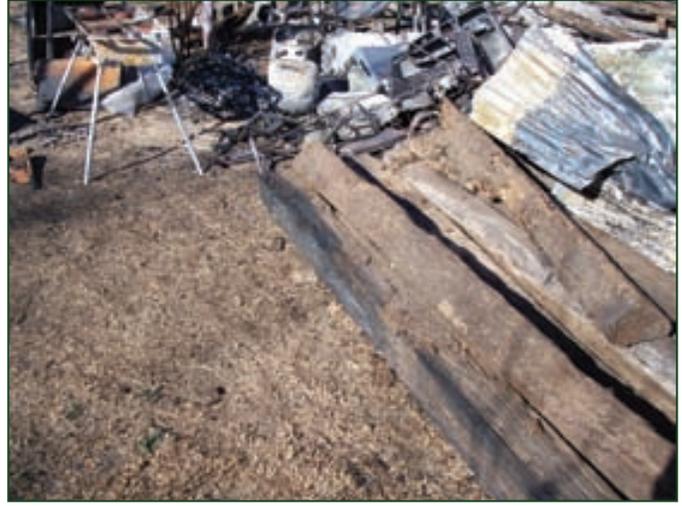
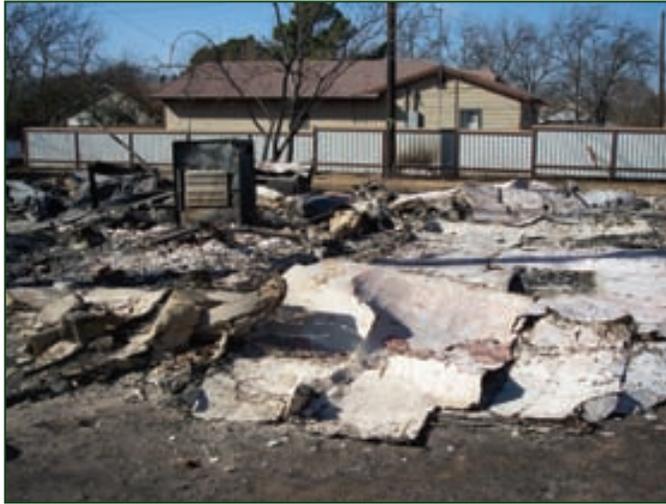
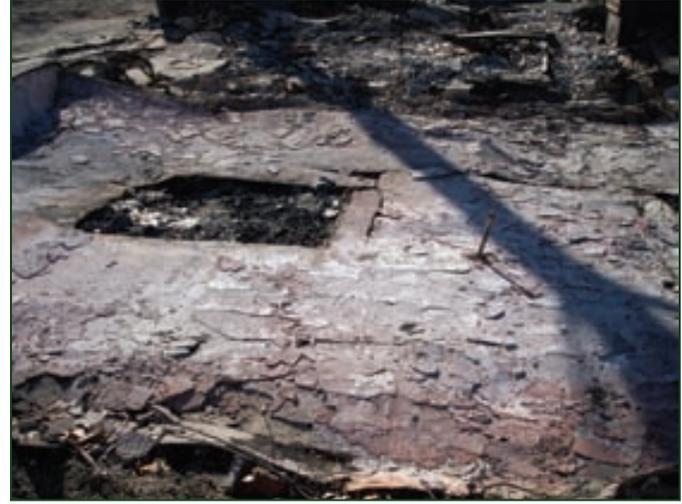
Pier-and-beam foundation

Landscape railroad ties carried the fire to the home and ignited the wooden beam foundation. Also, blown embers under the open foundation resulted in multiple points of exposure. Despite close proximity to hydrants, loss of the home occurred due to lack of manpower.

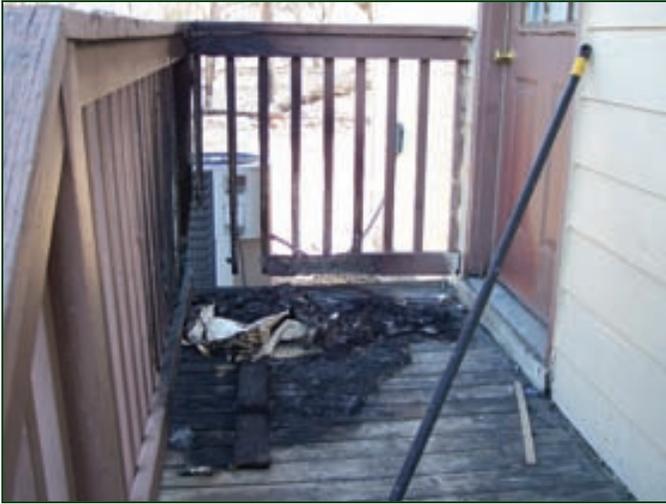
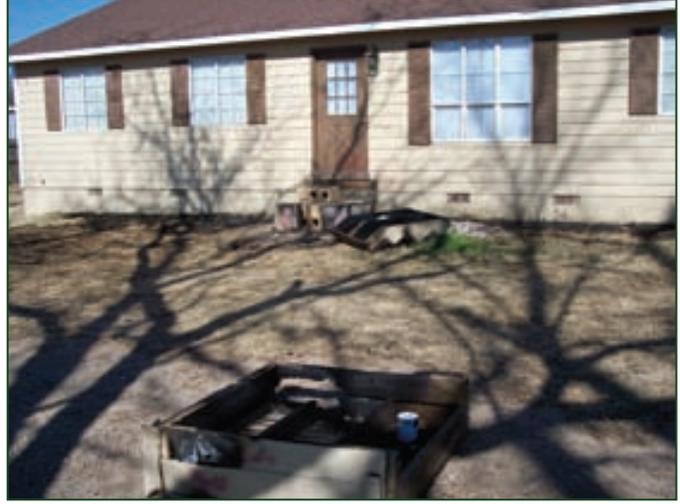
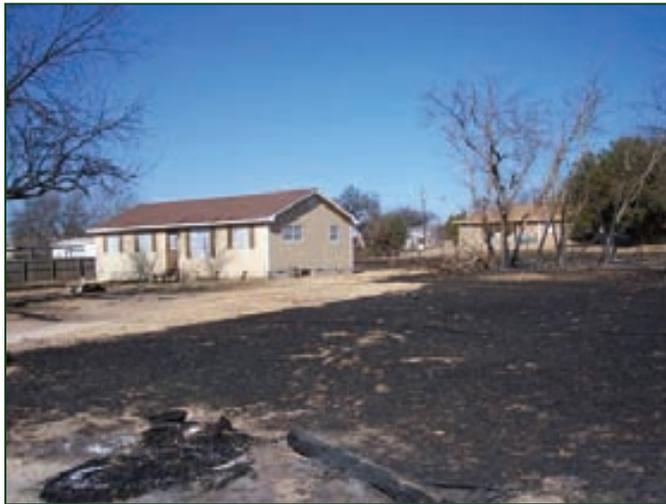
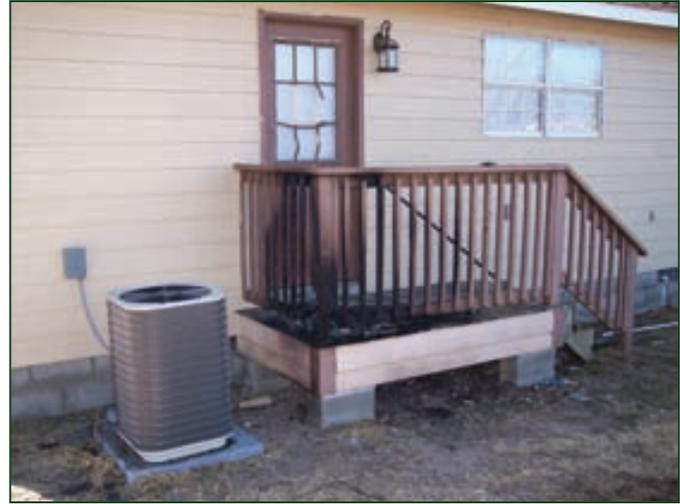
Cinder block/slab foundation

Although constructed of primarily non-combustible materials, such as composite siding and roofing, this home would have been lost had firefighters not returned to the home after the initial flame front. Suppression forces had to remove the wooden steps from the front of the home and extinguish the back porch. Both additions to the structure were constructed from combustible materials. Spotting onto flammable material on the porch generated enough heat to compromise the window framing which could have led to interior ignition. Notice that the majority of unconsumed fuel on the lot was near the home. Blowing embers created ignition potentials for the home. The back porch was the only other wood attachment on the structure, becoming a point of ignition; however, the fire was extinguished by fire department. It was noted during the reverse risk assessment that the majority of the fuel on the lot was unconsumed by the fire.

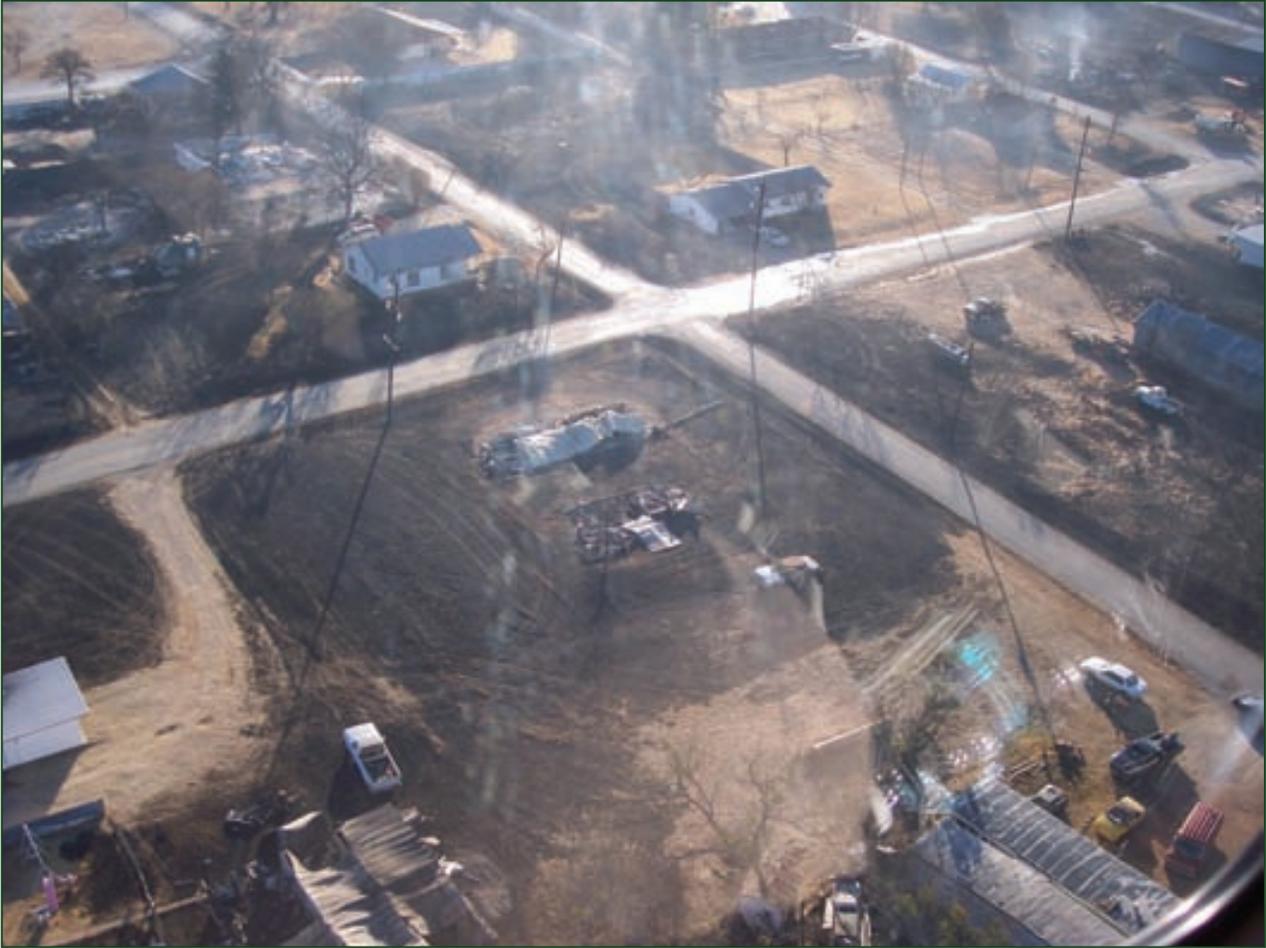
Homes in this area were impacted directly by the leading edge of the fire coming out of a Fuel Model 2, which is similar to study Area 2 and is located on the west side of State Hwy. 206. The flame front was still heading from the northwest. Eighty percent of the west side of Area 4, north of 4<sup>th</sup> Street and between 4<sup>th</sup> and 3<sup>rd</sup> along Avenue G, is thick overgrown juniper and mesquite with intermittent oak. Home construction became less slab and brick and was primarily pier-and-beam with wood siding, or mobile homes. Refuse and other debris in the yards and lots increased around these homes. The thick, overgrown vegetation on the west side of the study area is hypothesized to have slowed the flame front, allowing the fire to gain in heat output productions, possibly contributing to a major cause of the higher number of houses lost in this section.

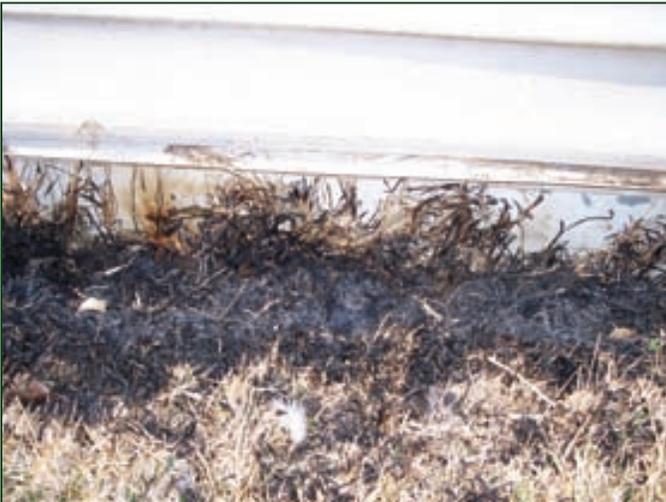
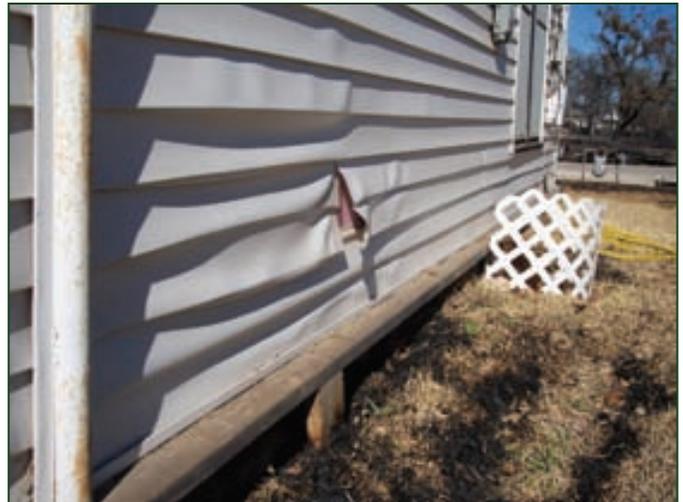
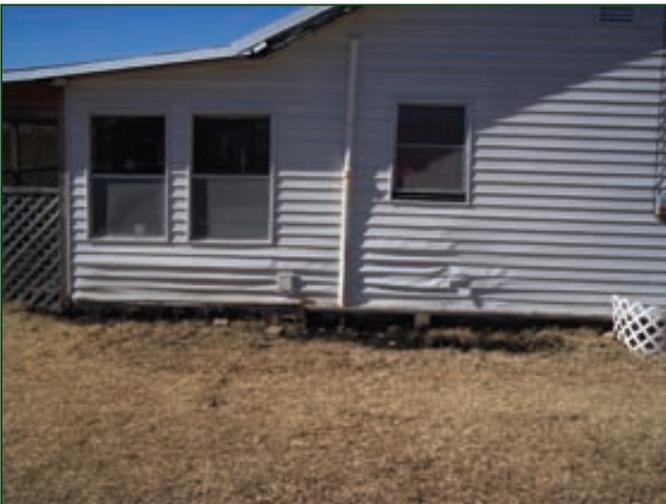
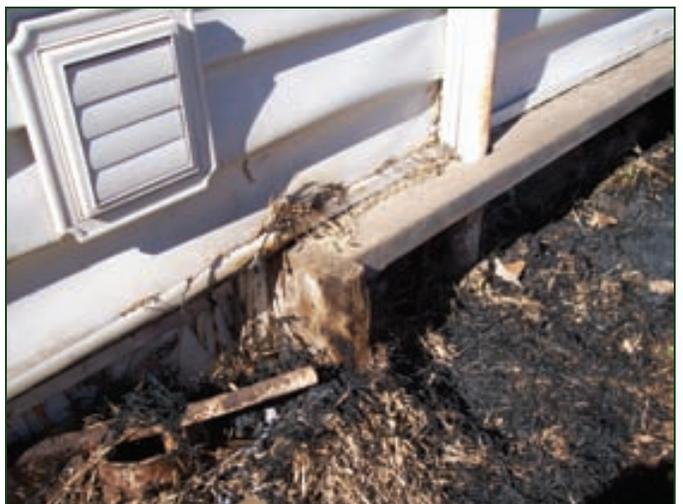
- Metal roof with open wooden soffits
- Vinyl siding with grass growing under siding
- Pier-and-beam foundation
- Wooden front porch
- Wooden lattice on the back porch
- Lost barn and outbuilding

The homeowner stated that wind shifts from west to north brought the fire to the house. The fire department initially started suppression. Observations noted fire brands being carried by the wind to the side of the house and dropping them into the grass. Grass growing up under vinyl siding ignited, and consequently, the heat began to melt the siding and ignited the lattice on the back of the home.

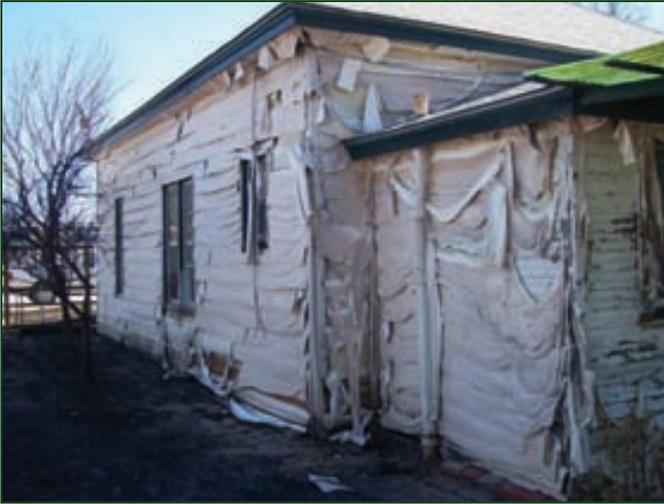
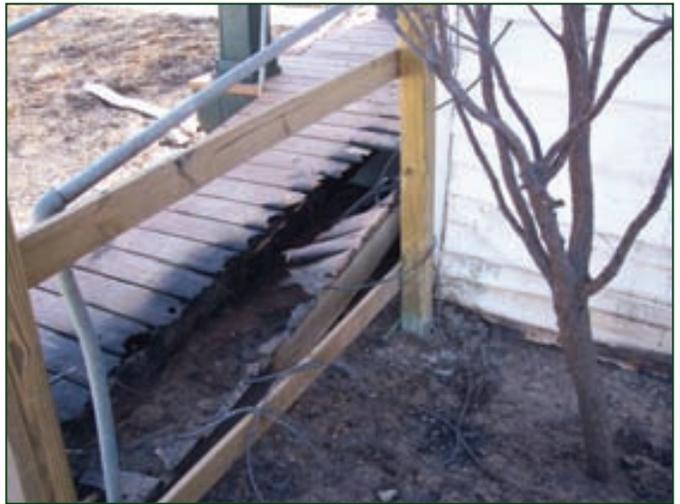
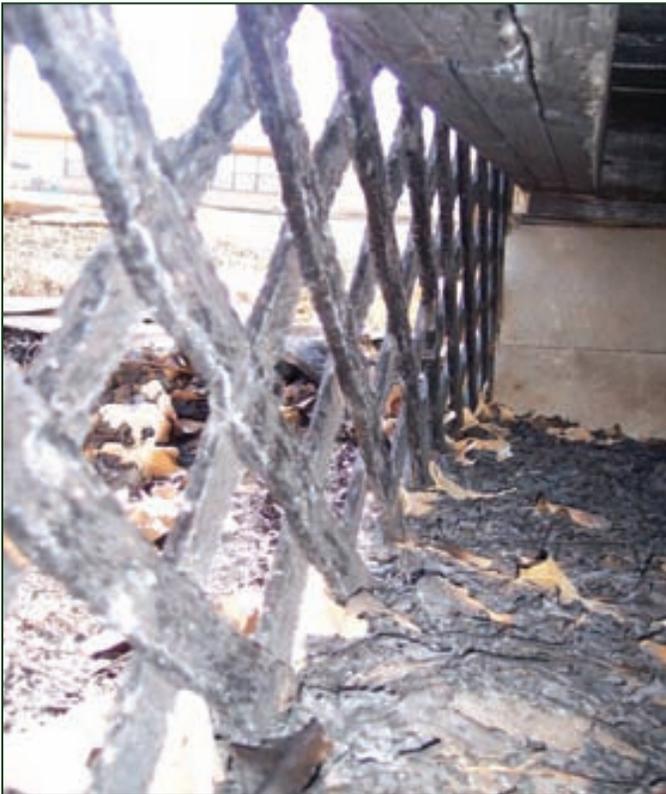
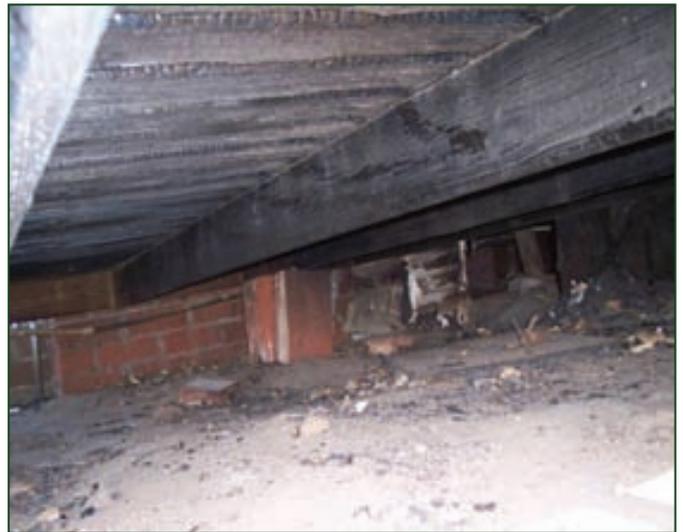
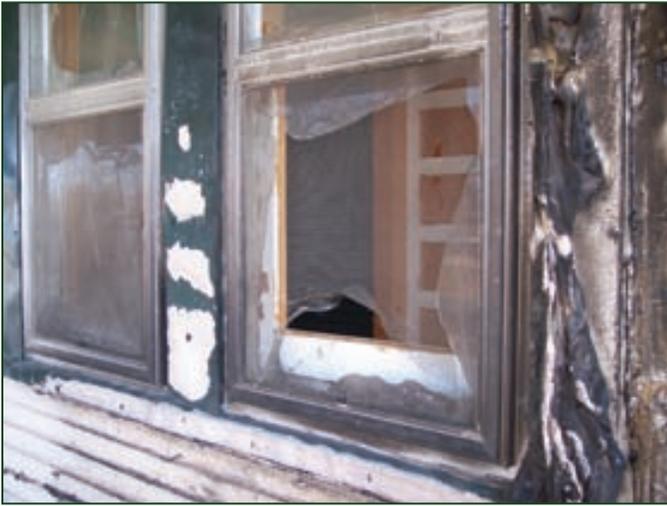
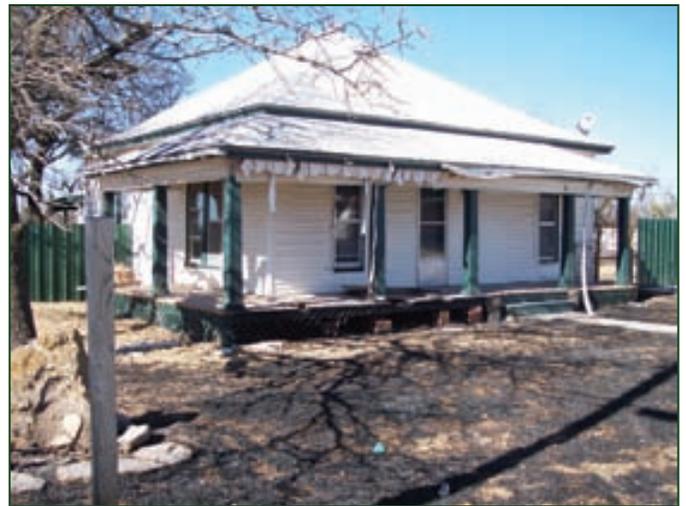
Wooden porch with lattice and wheelchair ramp burned

During the reverse risk assessment, the fiberglass overhang on the back porch suggested the sheer number of firebrands that assaulted this structure during the fire. There was increased risk to this home due to roof construction. Unscreened lattice work around the home allowed for the accumulation of leaf litter and debris. The fire generated enough heat to ignite the back porch and char the pier-and-beam foundation. It would be reasonable to assume that if the lattice work had been screened, this home would not have sustained ignition. Although the screens did not melt, heat from the burning porch compromised the single-pane windows. This structure was retro-fitted with vinyl siding, which when melted, exposed the original wood siding. No barrier protected the exposed wood siding which allowed the home to be vulnerable to radiant and conductive heat. This home was saved due to structure protection after the fire front passed.

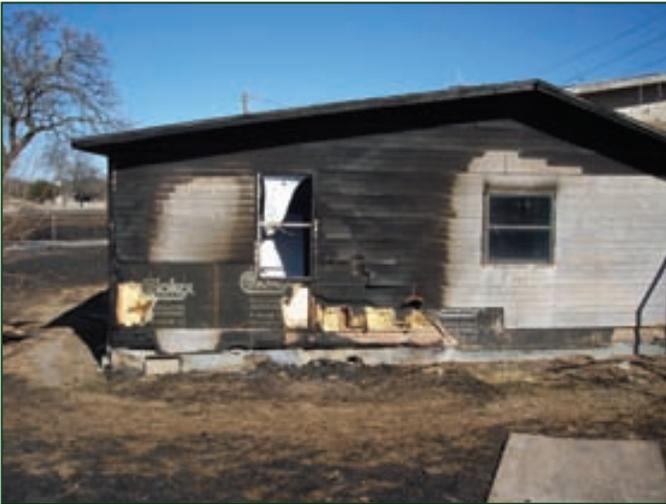
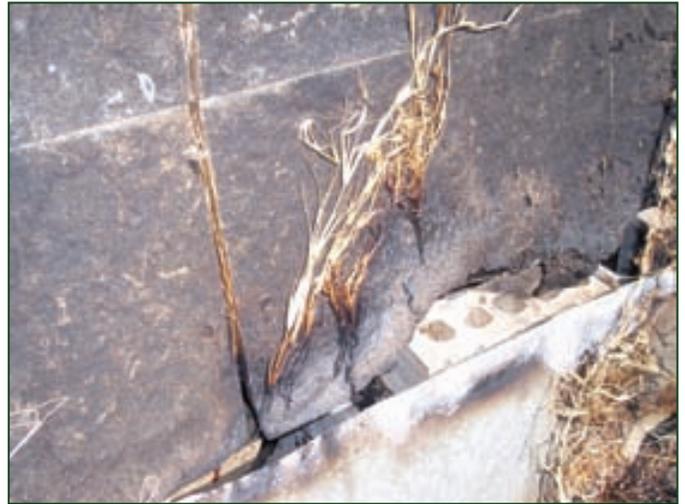
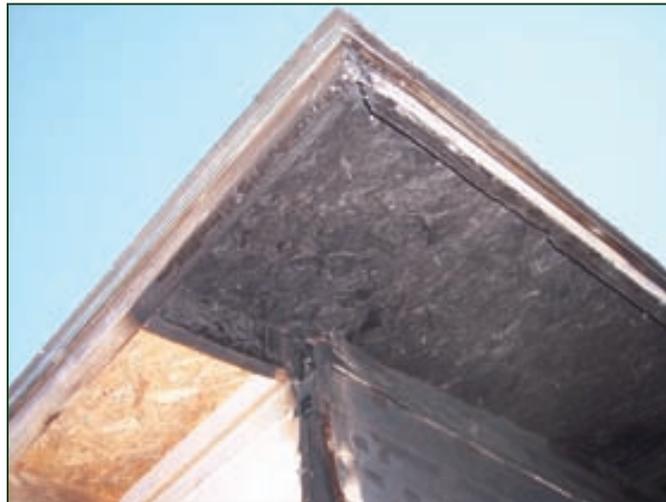
Grass growing under wood siding acted as a fuse for fire to ignite the siding and subsequently ignited the eaves. Note the break in fuels between the yard and the home caused by a dog run. Only a small amount of fuel was left adjacent to home, where fire spotted over the dog run to the grass next to the home. Single-pane windows, once compromised, permitted fire and heat to enter the home.

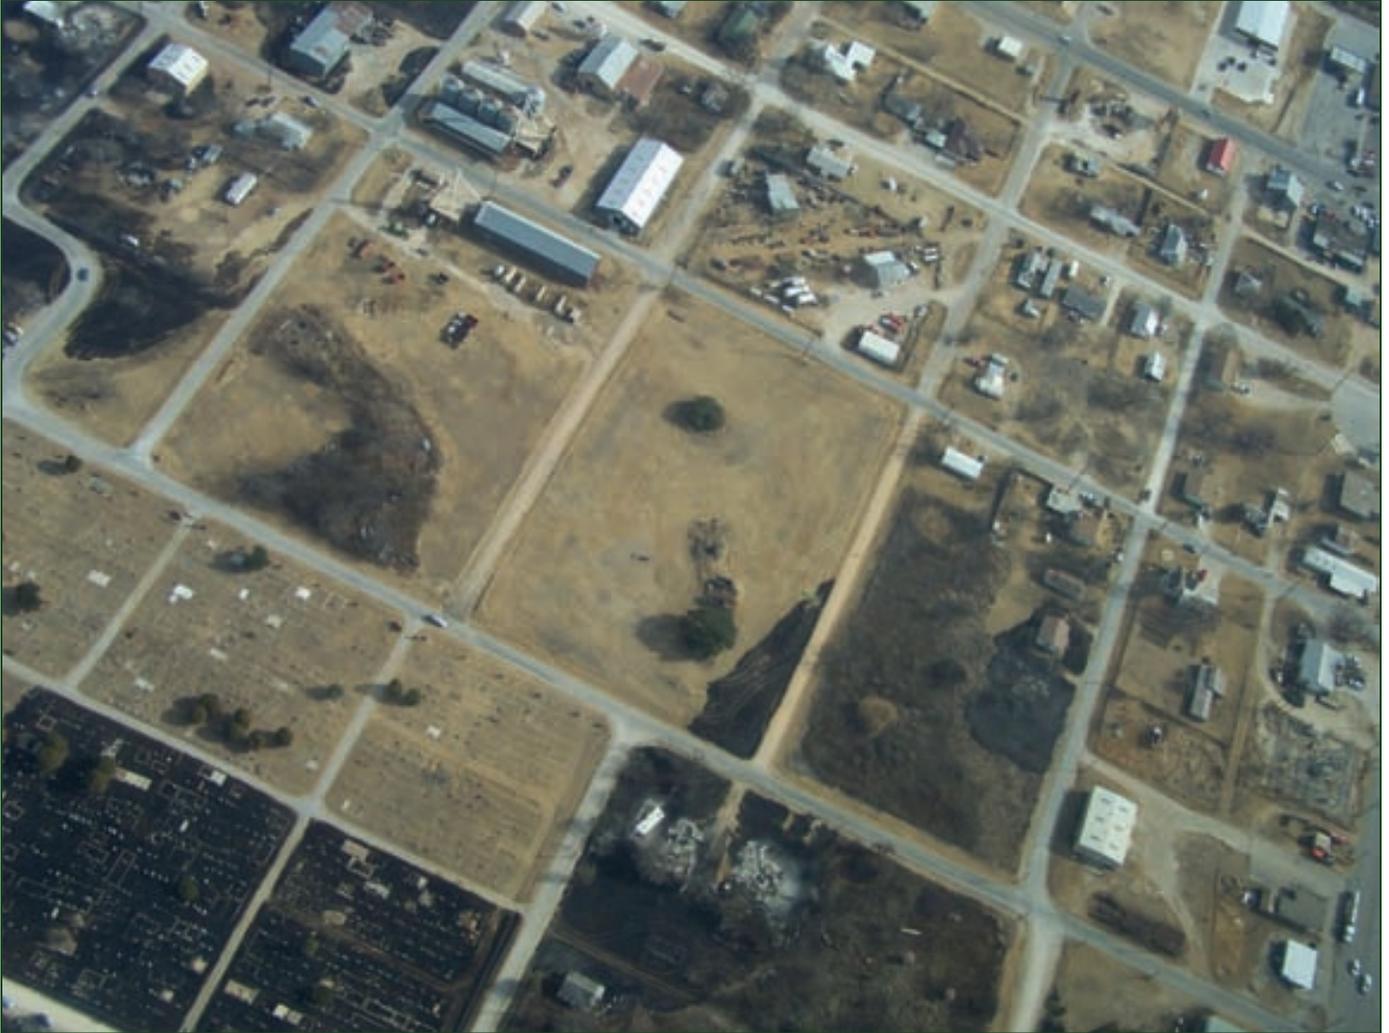
The fire came from the northwest over fields of waist-high native grass into an overgrown oak and juniper field. Coming out of a Fuel Model 9, a quarter mile of Fuel Model GR4 grasslands expanded out in front of the homes in this area, located on the west side of State Hwy. 206. To the east of the native grass field, there are grazed pastures, which perhaps shielded many structures on Live Oak St. Many of the homes in this section were either older pier-and-beam or mobile. Excessive debris at the southern end of the overgrown oak/juniper patch led to the total loss of structures. The socio-economic conditions of excessive debris, lack of landscape maintenance with regard to defensible space and fabricated homes in this section may have led to greater home loss.

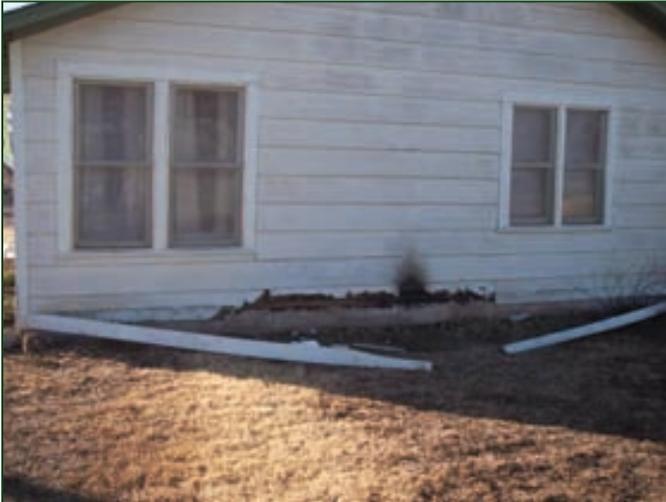
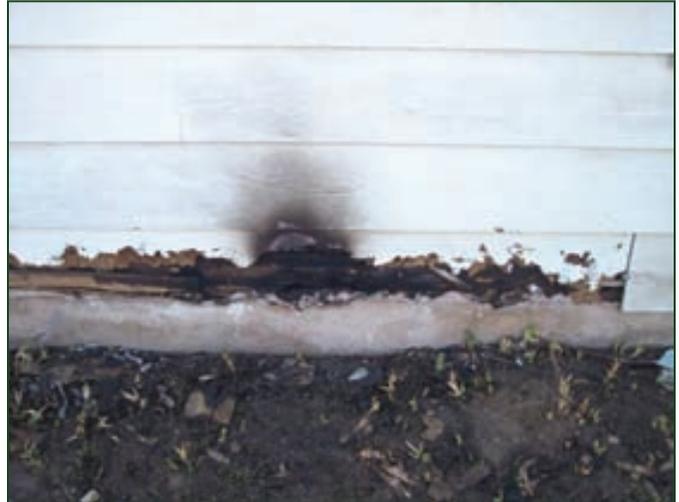
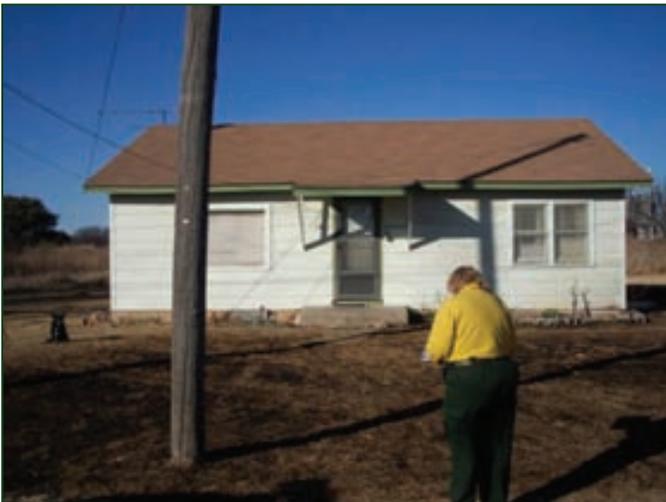
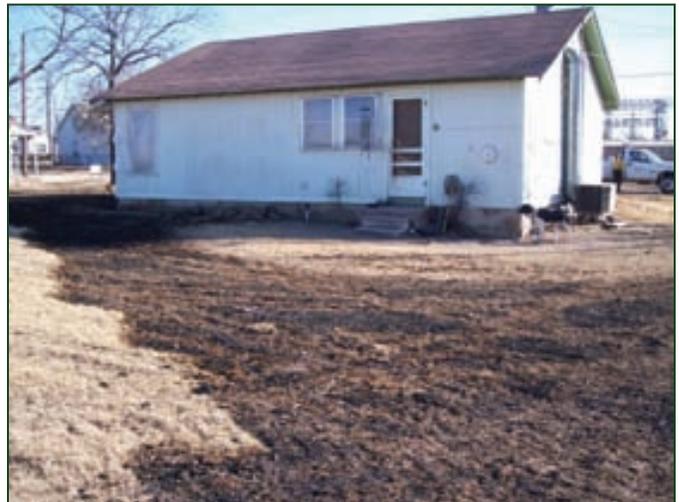
Concrete slab

Suppression conducted by volunteer fire department

Dog runs on the front and back side of the home created a fuel break, keeping the fire from making contact on three sides of the home. Fire traveled to the side of the home where the dog's movement was restricted, allowing the fire to come in direct contact with the wood siding home. Radiant heat was significant enough to compromise single-pane windows and melted vinyl blinds.

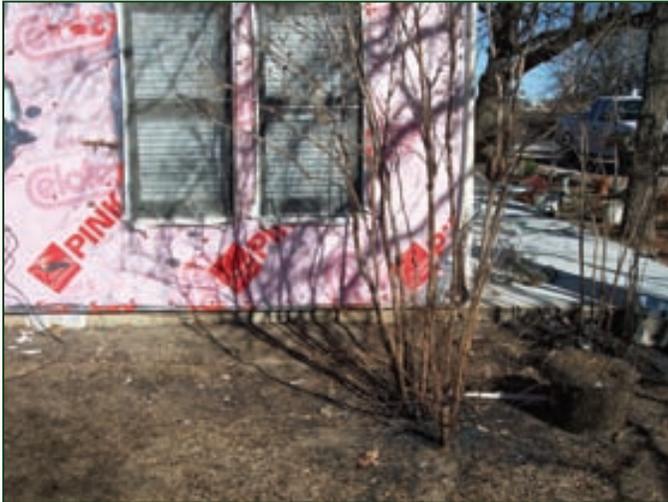
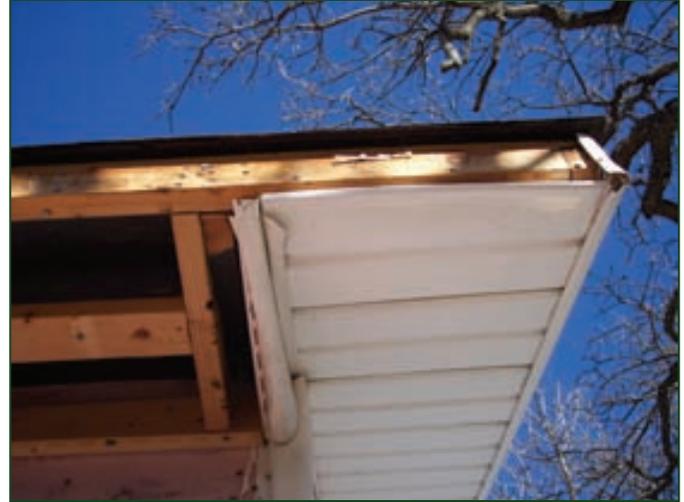
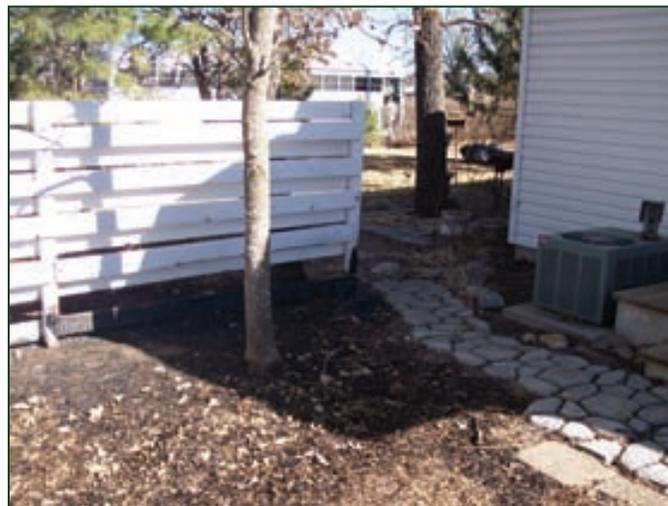
## A Closer Look at Home 100:

Concrete slab

No hydrants available, homeowner saved house

Fire approached this house from the south and immediately melted the vinyl siding, exposing the insulation and wooden frame. A stone walkway and concrete sidewalks around the remainder of the home protected the sides of the home and prevented the fire from making contact. The lack of a barrier allowed the backside of the home to be compromised and ignitable by the fire. The homeowner provided structure protection and prevented further home ignition. The stone walkway acted as a barrier, preventing the fire from spreading in the grass and along the fence and making contact with the home. The firewood rack, although less than 30 ft. from the home, had scorched grass underneath but did not ignite due to the metal rack preventing direct flame contact from the grass fire. Vinyl siding and soffits melted, exposing insulation and wood overhangs, increasing the potential for the wood frame to ignite

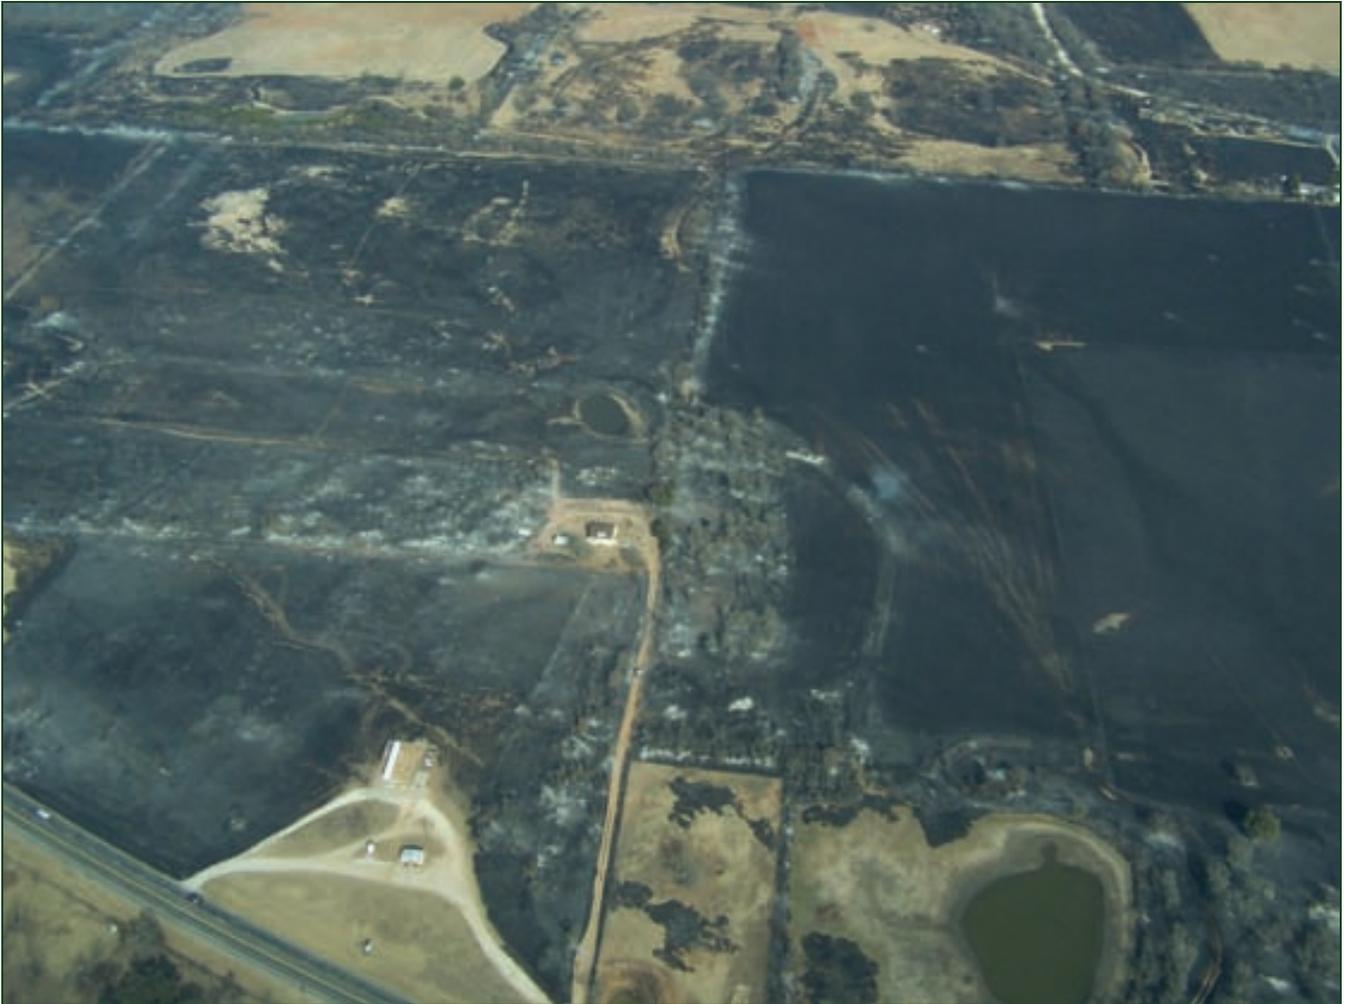
Three-and-one-half miles west of Cross Plains was the location for the point of origin for the fire. An assumed discarded cigarette into model GR4 fuels on the south side of State Hwy. 206 resulted in an ignition of dead winter grasses. Despite the quick response of fire departments arrival on scene the fire quickly spread through the grass, which was a GR4 fuel. At the time of ignition, 1-hour dead fuel moistures were calculated at 5%, surface rates of spread were estimated at 2.4 mph, with flame lengths in this grass model observed at 13 ft.

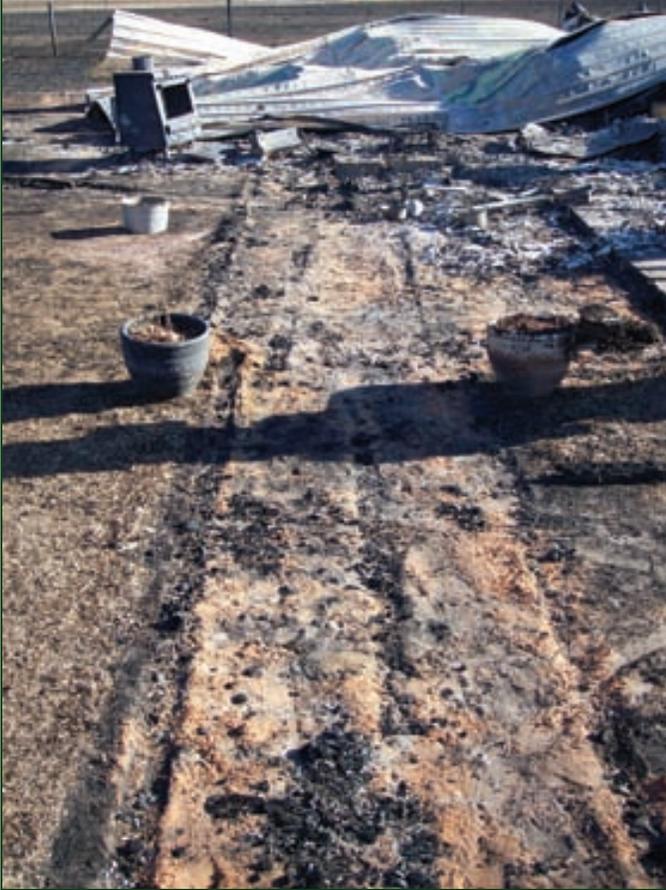
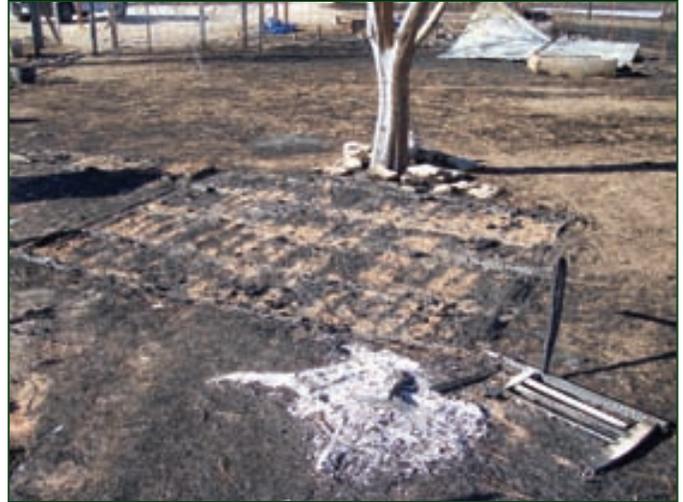
Cattle panel fencing

Vegetation around the entire perimeter of the home was minimal with short grass being dominant. The ignited grass produced enough heat to ignite a wooden walkway leading to the front of the home and wooden deck. The wooden walkway acted as a fuse leading to the home and causing ignition. The wooden front porch and walkway faced the oncoming fire front. This was the first home lost despite suppression efforts.

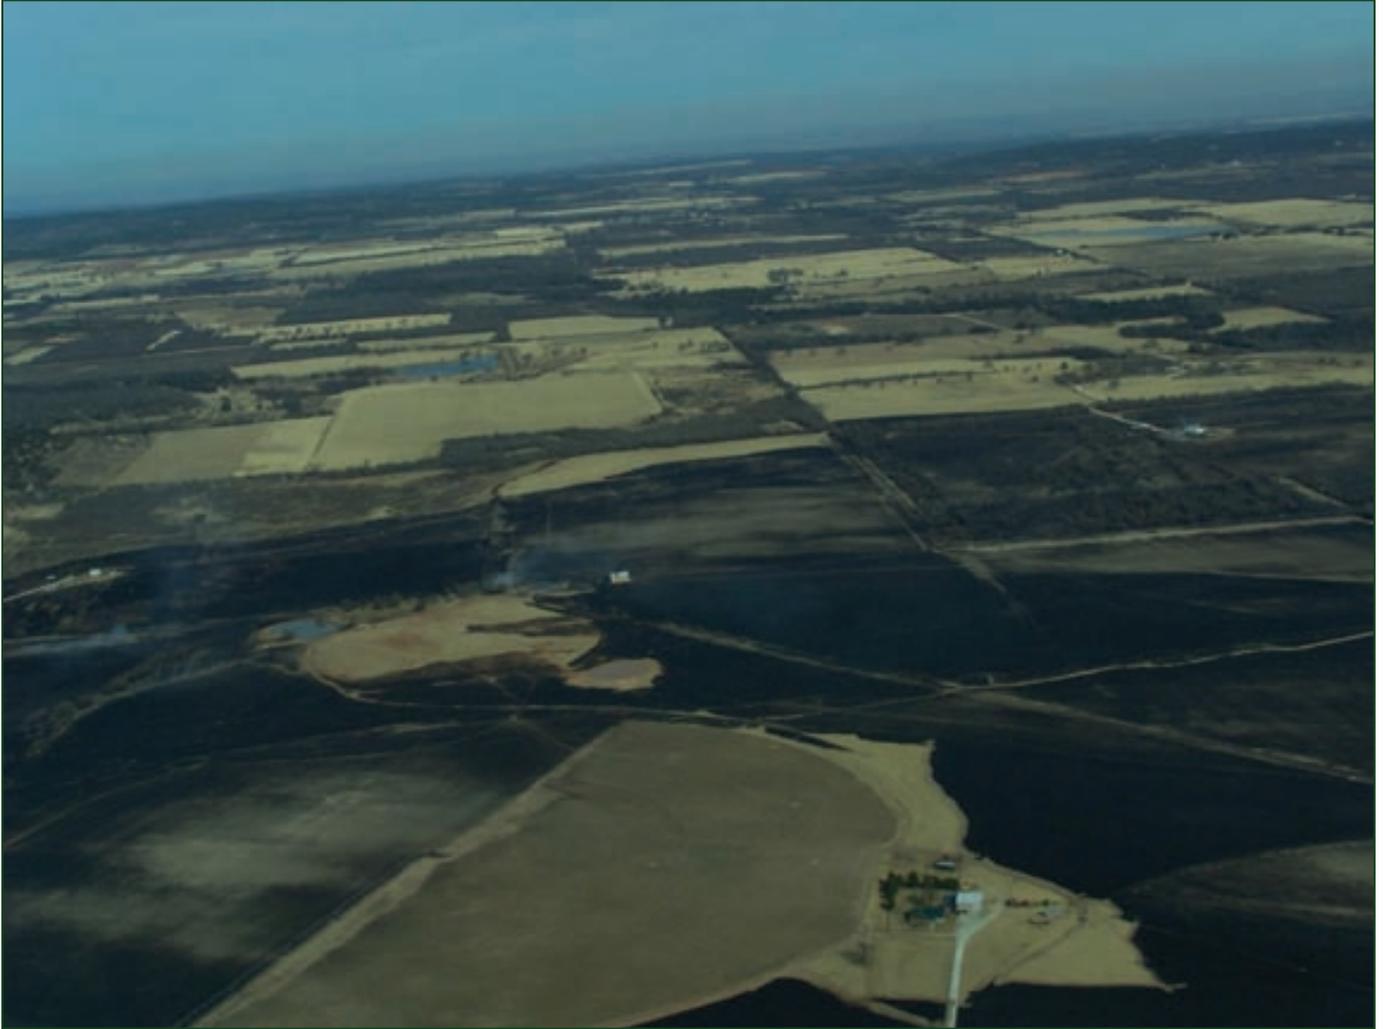
A third wind shift occurred during the evening hours of the event, pushing the fire in a southeasterly direction and causing the fire to turn back on itself, consuming homes on the east side of town and threatening numerous businesses. Despite evening conditions of slightly increased RH and decreased wind speeds, fire behavior was still active in the GR4 grass Fuel Model predominate in this area, along with motts of hardwoods. The fire consumed mobile homes and older pier-and-beam foundation homes.
