# Cross Plains, Texas Wildland Fire Case Study

This document was prepared by Texas Forest Service – Urban Wildland Interface Division and was completed on May 16, 2007. Any reproduction of this document should be copyrighted to Texas Forest Service.

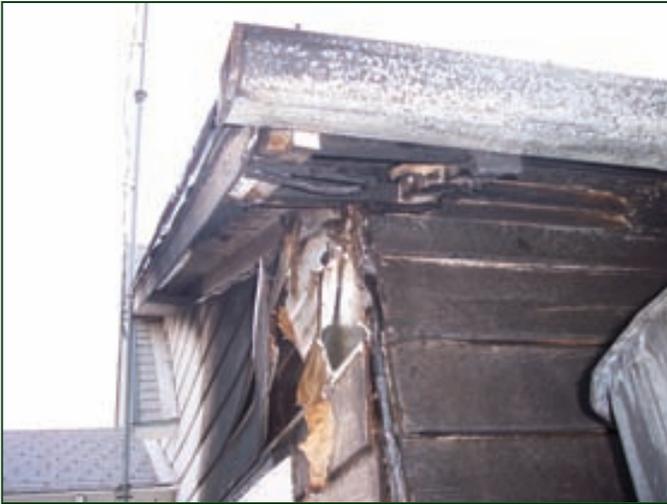
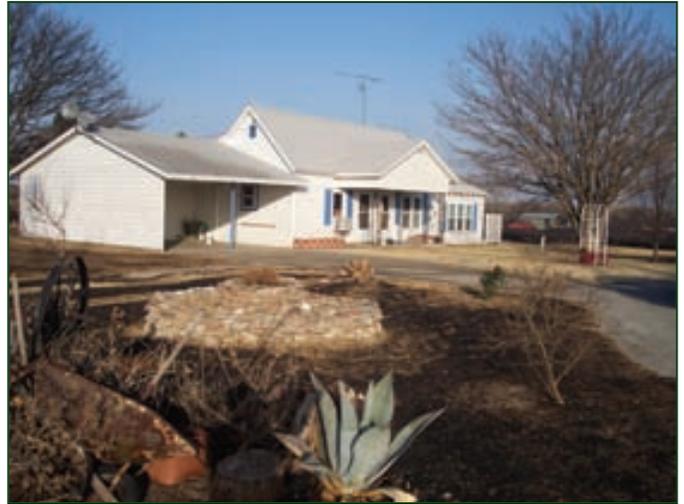
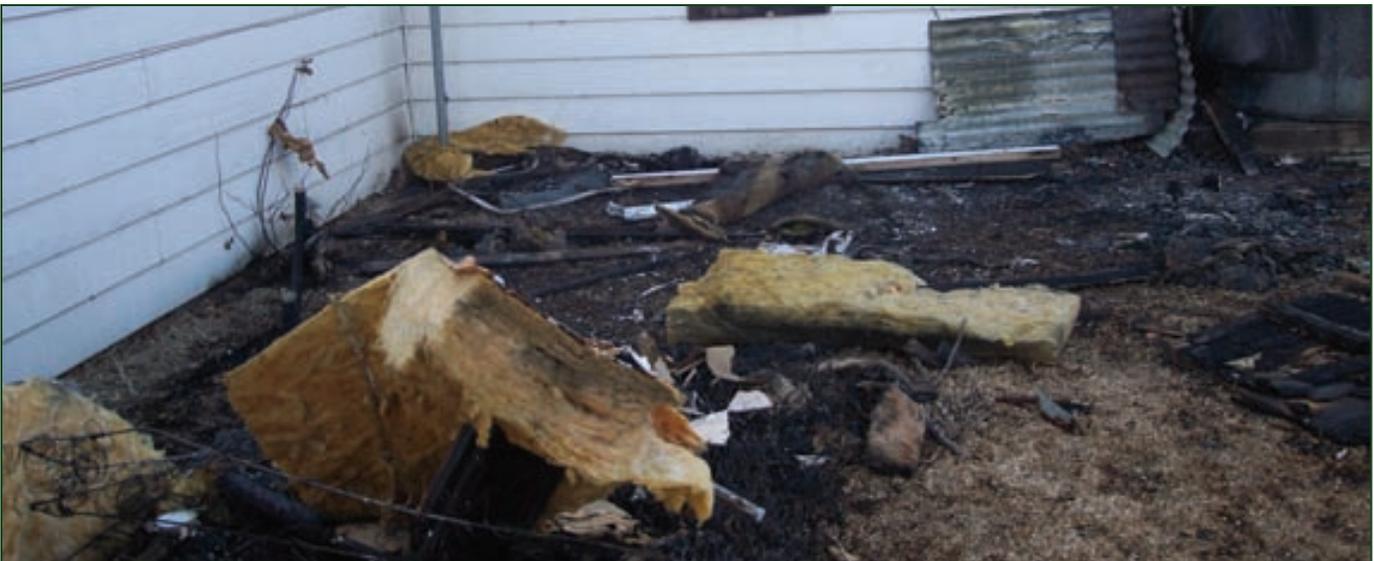
Composite roof

Despite numerous spot fires observed around the front of the home, ignitions actually occurred on the backside of the home. The large amounts of debris within close proximity to the home are credited with contributing to the ignition of the home.

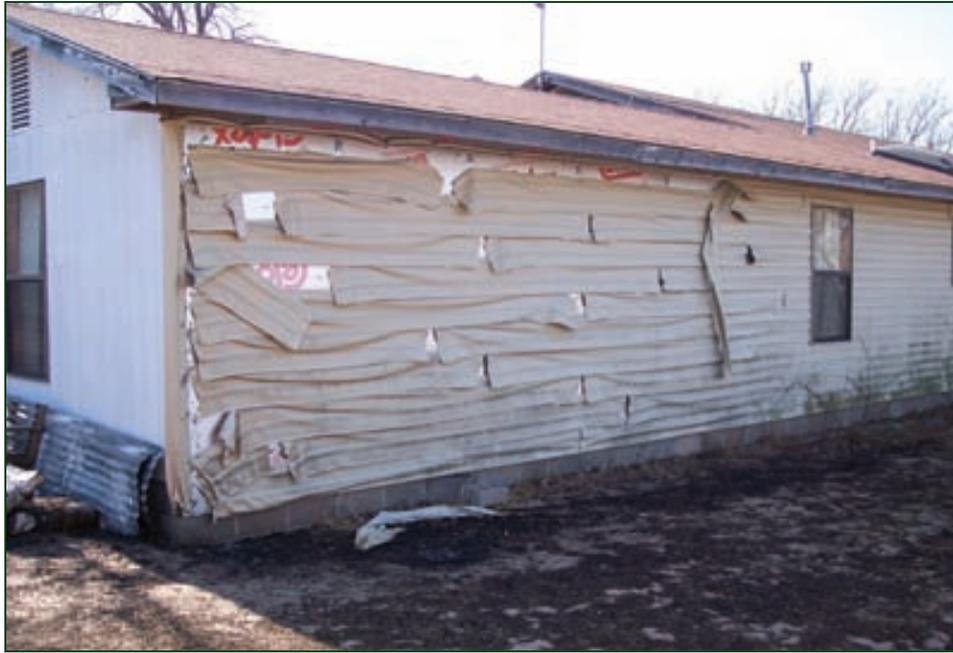
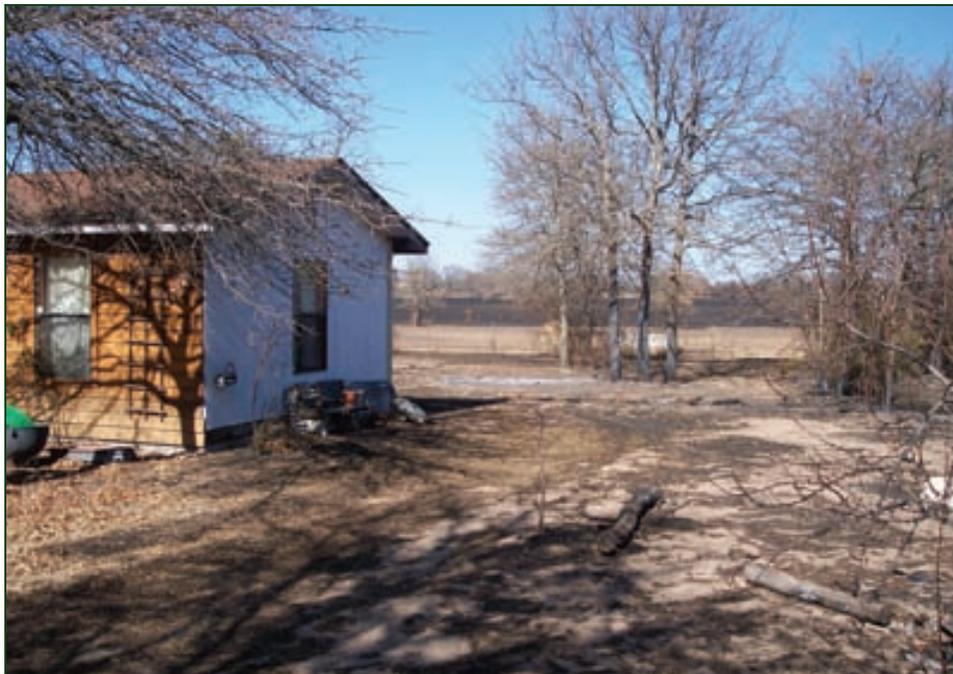
Composite roof

The lack of a break in fuels allowed the fire to burn directly to the side of the structure and melt the vinyl siding. The homeowners were forced to evacuate, but family members returned after the initial fire front passed to continue suppression efforts, saving the home.
